# SOUTH FORK TOLT DAM: SPILLWAY MODEL STUDY

Water Resources Series  
Technical Report No. 60  
June 1979

**SOUTH FORK TOLT DAM: SPILLWAY MODEL STUDY**

TOLT RIVER DAM SPILLWAY

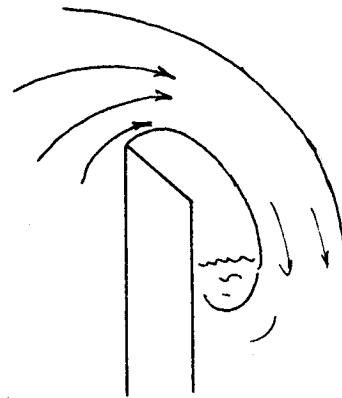
*Tolt Ring Gate Lip  
(air not completely  
evacuated)*

was exhausted suggests a sudden change in pressure around the gate, perhaps analogous to the "gate downpull" phenomenon, but with the force direction upward. The weir crest may act as a lifting vane when completely submerged. To check this supposition, the square edges of the gate bottom face making contact with the spillway crest were rounded off, and the gate was turned upside down, with the now sharp weir crest sitting on the spillway crest. The gate was quite stable in this position.

If the gate must serve as a flow control structure, it should be redesigned. The crest should be re-shaped, full ventilation provided for, and a skin plate should cover the inside stiffener rings and any other projecting surfaces.

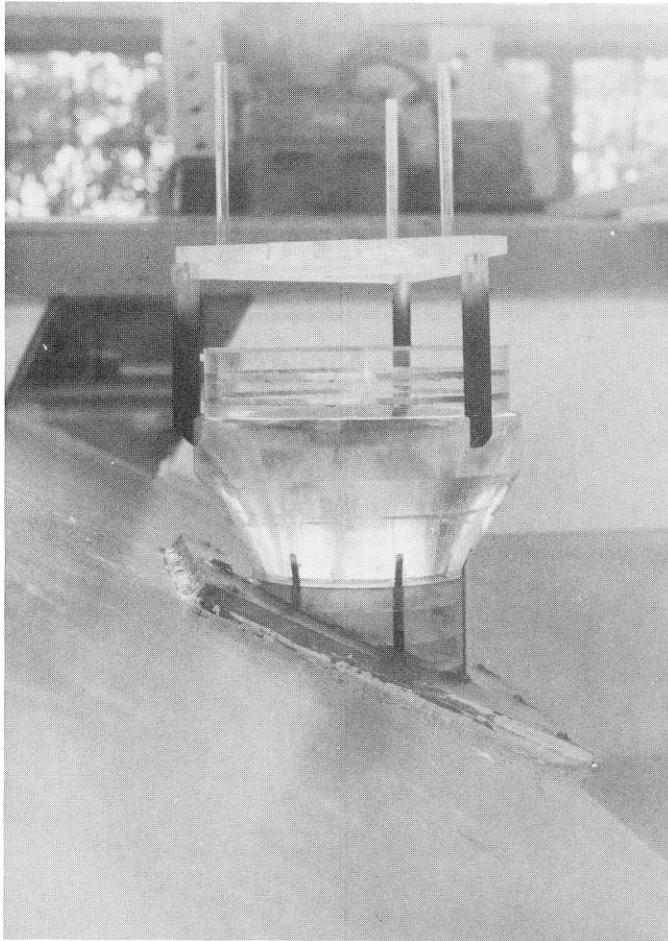
Figure 2. Spillway, Ring Gate in Lowered Position,  $Q = 10$

un-vented model, the air pockets that form and break away indicate unsteady hydrodynamic forces, with structural vibrations a probably consequence. An upward lifting force develops due to the shape of the gate crest, with some force contribution from the stiffener rings very probable. The piers alone do not make the gate function as a ventilated weir. Ventilating the gate eliminates the upward force due to the negative pressure field in the vicinity of the crest and lowers the sound level for flows up to about 11,000 cfs. Just one 1/4-inch tube in the model provided adequate ventilation, so one 12-inch pipe behind each pier in the prototype would be sufficient.

The ring gate as now designed should not be used as a flow control structure, either with flow over the top or as an undershot gate because of the inherent unsteady hydrodynamic forces that could lead to structural vibrations, and because of the unsymmetrical pressure loadings caused by variable depths around the spillway.

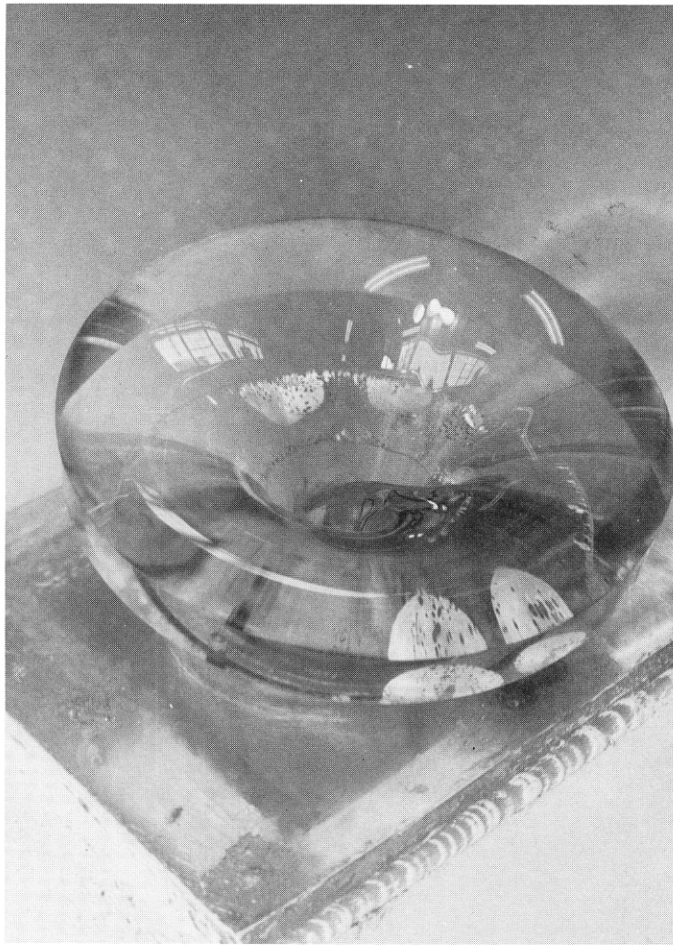
Figure 4. Spillway, No Piers, Rooster-Tail on Dam Axis Side

The sloping dam face has a marked influence on the approach velocities to the spillway. The upper nappe develops a rooster-tail like profile on the dam axis side, as illustrated in the photographs of Figures 4 and 5 and profile plots of Figures 14 and 15. The dye patterns in Figure 6 show the curvilinear flow, the absence of radial symmetry, and a stagnation zone along a vertical plane normal to the spillway circumference at its nearest point to the dam

axis. This point was the location recommended in the 1958 report for one of the three piers supporting the gate structure. Any tendencies for vortex motion are damped out in the vicinity of this stagnation plane.

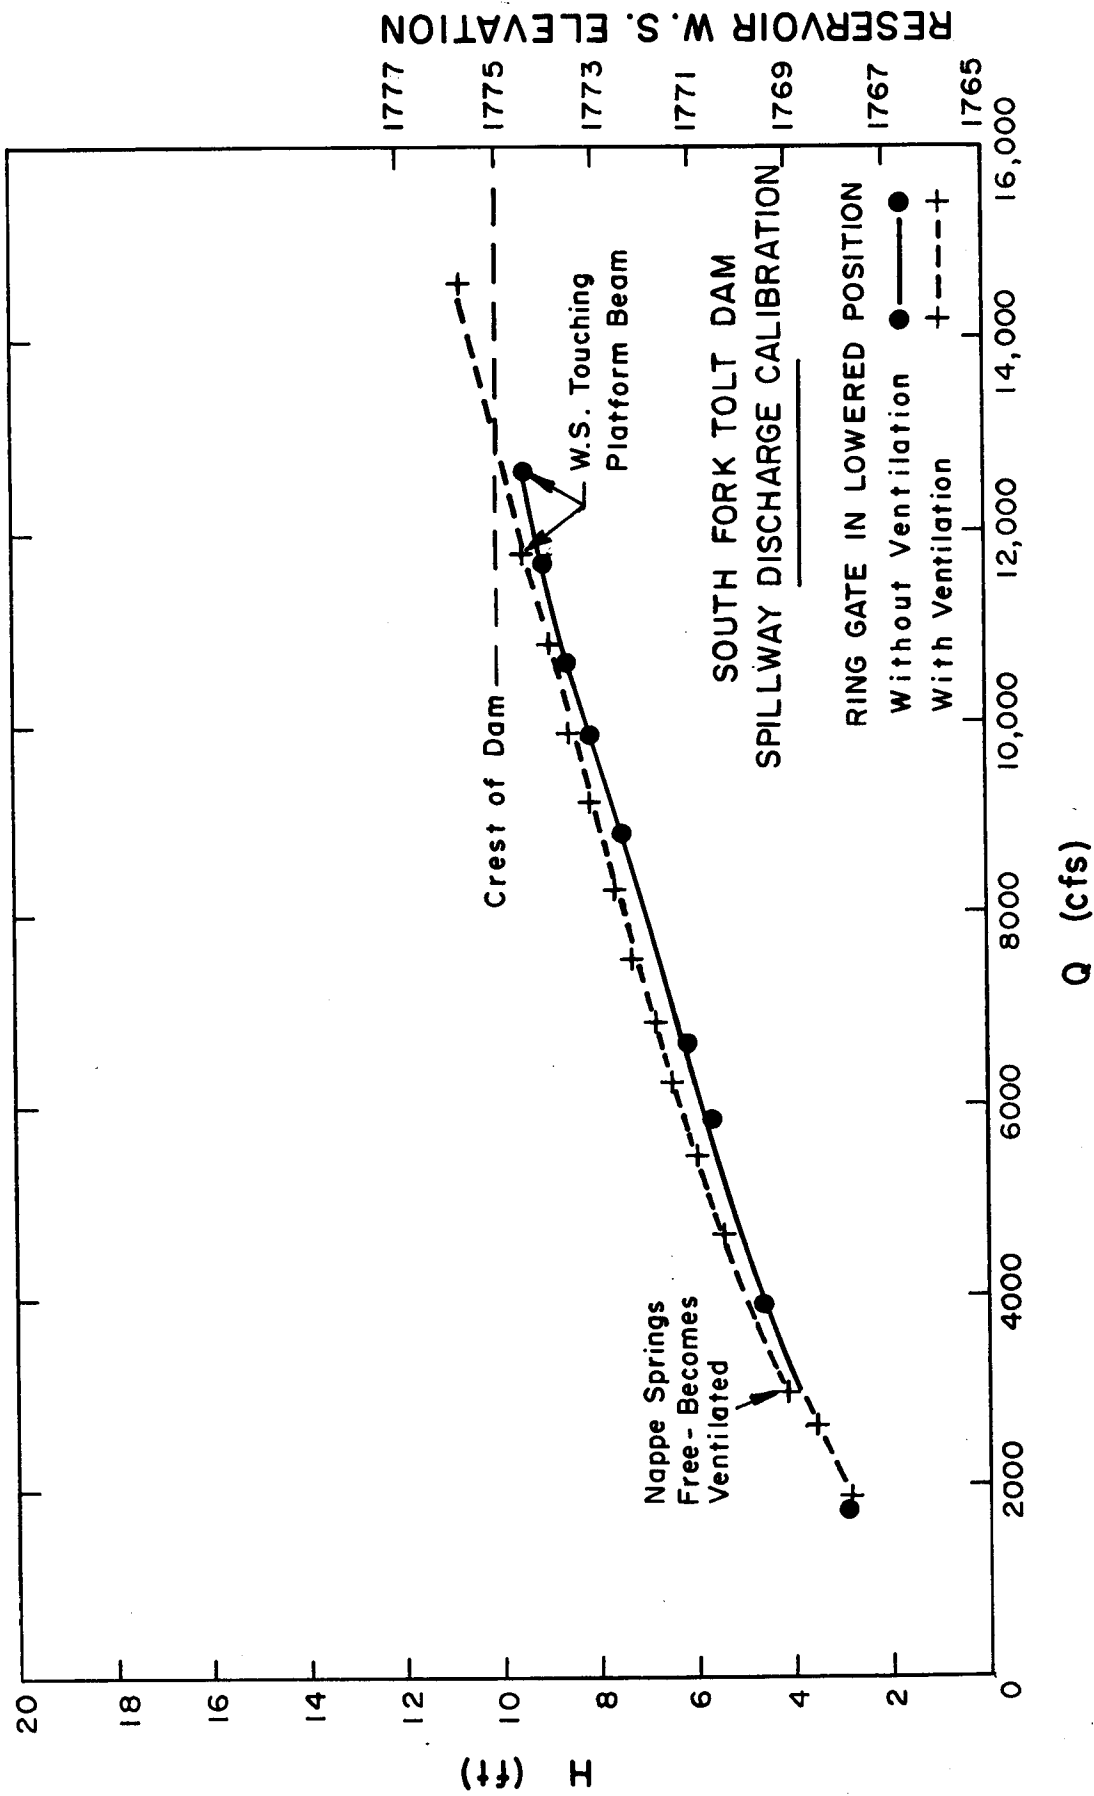
Figure 10. Spillway Rating Curve: Ring Gate in Lowered Position

The calibration test results with the ring gate in position on the dam crest are shown in Figure 10 for the two cases, with and without ventilation provided to the underside of the nappe. In this test series, the ring gate was sealed to the dam crest with a silicone cement. With the upper edge of the ring gate now serving as a sharp-crested weir, the jet initially trapped an air pocket above the spillway. This pocket decreased with time and increasing flow rate. For the sequence given in Table 4, the air pocket was depleted by the time the flow rate had been increased to about 5500 cfs. The flow rate has to be large enough, about 2000 - 2500 cfs, for the nappe to spring from the ring gate and strike the spillway for the air pocket to be formed. Bubbles were noted inside the gate, the flow in the shaft became quite noisy, and vibrations could be felt in the structure as the flow rate was increased. Some gulping in the spillway shaft started at a flow of about 7000 cfs. The symptoms

of a non-ventilated weir were quite evident. The water surface reached the bottom of the platform beam on the dam-axis side at a flow rate of about 12,000 cfs.

The gate support piers did not create the conditions necessary for the ring gate to operate as a ventilated weir, so a tube was inserted behind each pier. These were 1/4-inch diameter (one foot prototype) held in place by slide-fit holes in the gate platform. Their location in the wake region behind the piers is advantageous since there is no interference with the flow over the spillway, the force on the tubes is lowest, and the pressure field is favorable for aerating the spillway jet. The top of the tube was open to the atmosphere, and the bottom of the tube was located below the lower stiffener on the inside of the ring gate. Just one tube supplied enough air for complete ventilation. The ring gate with the tubes is shown in the raised position in Figure 3. For the case with the ventilated ring gate, shown on Figure 10, an increase in head of 0.2-0.3 feet above that for the un-vented case is needed to discharge an equal flow (above about 4000 cfs). At a flow of 3000 cfs, the nappe becomes fully ventilated and remains so to the maximum flow tested. The water surface touches the bottom of the platform beam at a flow just under 12,000 cfs, and reaches the dam crest elevation of 1775 at a rate of 14,000 cfs. With ventilation, the flow was steadier, and much quieter than in the unvented case. No measurements of air demand rates were attempted.

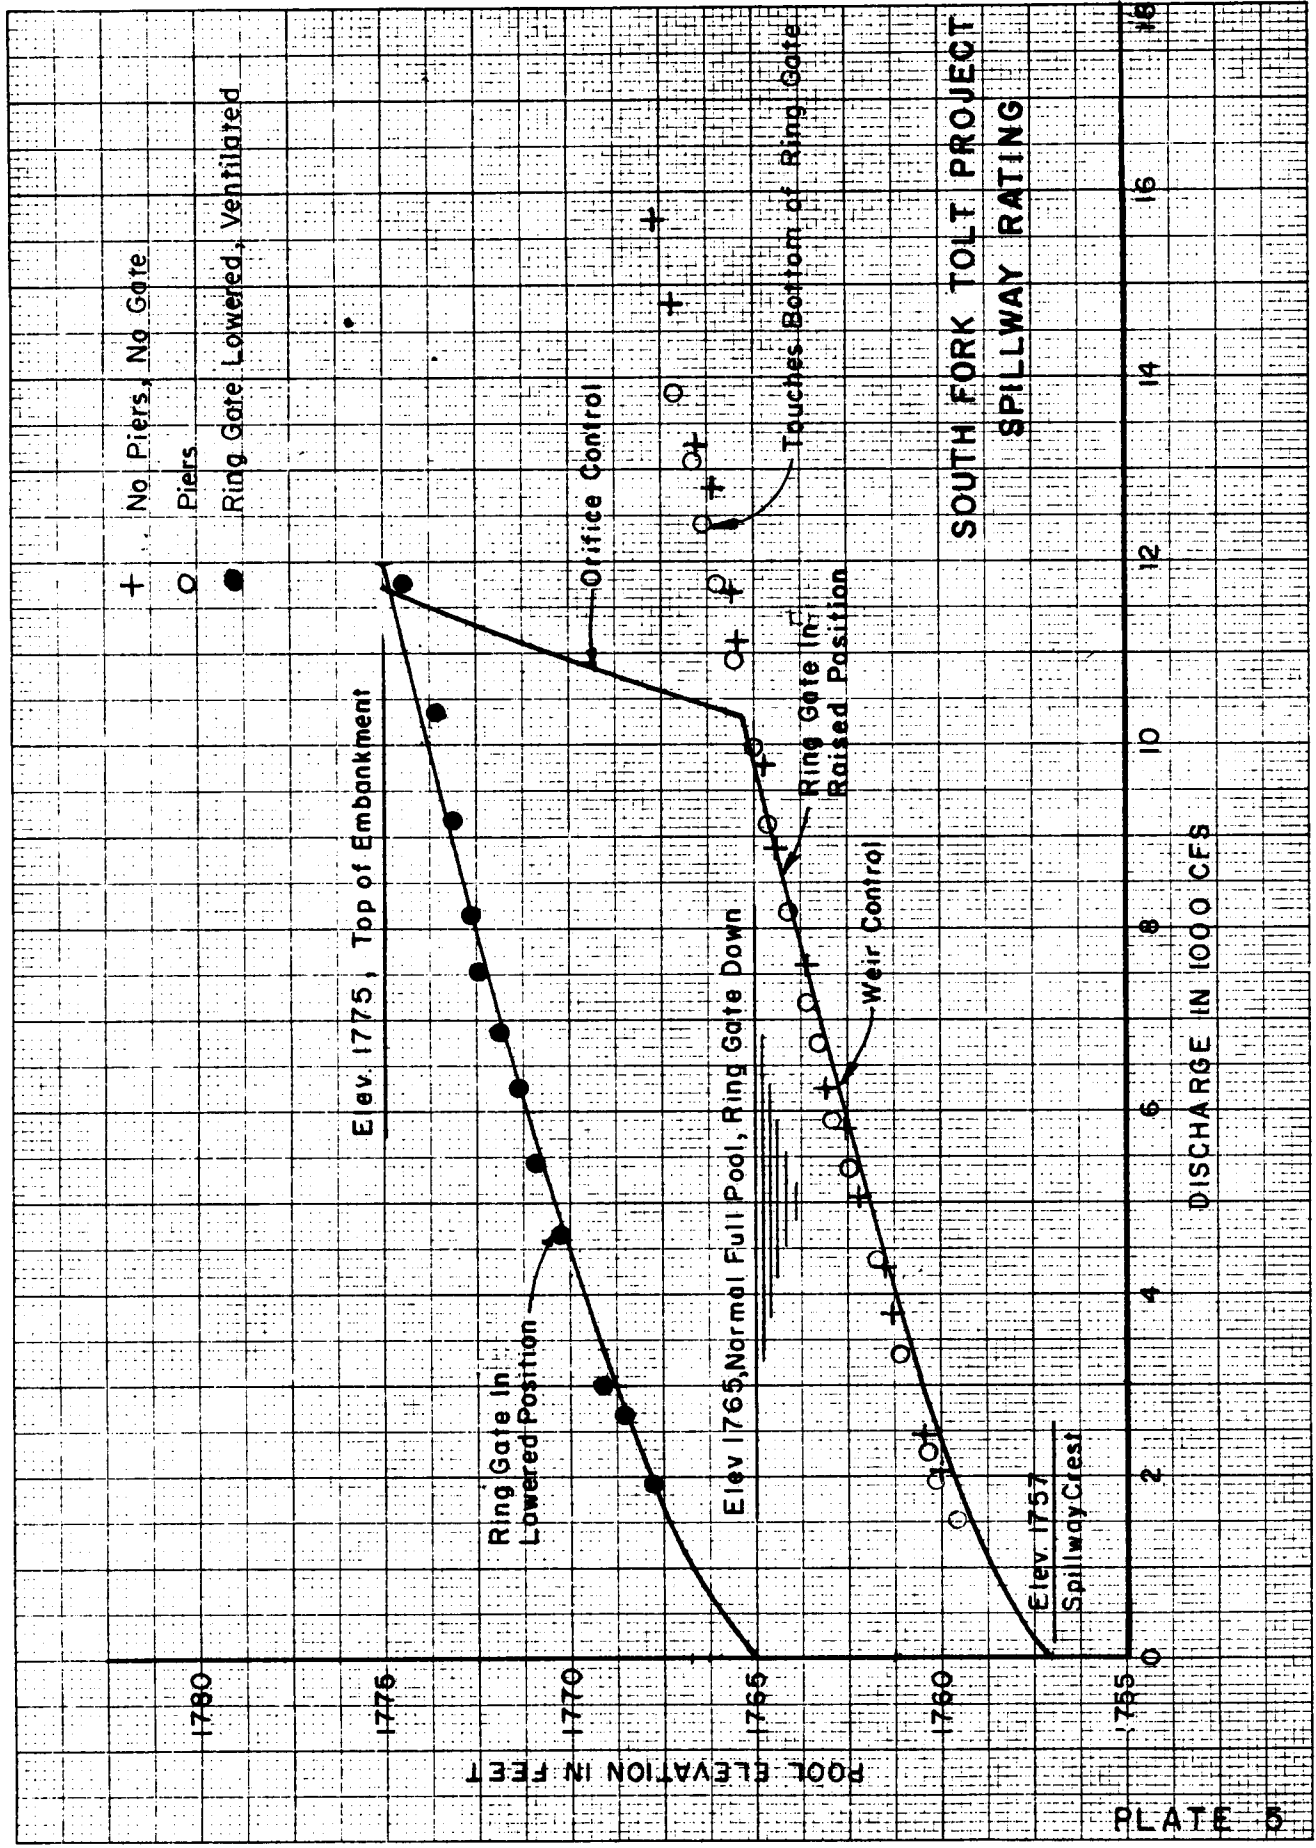
Figure 11. Comparison of Predicted and Experimental Spillway Rating Curves

The data points from the model fall slightly above the curve predicted in the Corps of Engineers Phase 1 Report (Figure 11) for the case with the ring gate in the raised position for flows less than about 8000 cfs. The

departures may be due to a different design procedure used for the spillway as constructed from that selected for prediction in the Phase 1 Report (page 14). The significant difference between the two curves, however, lies in the fact that the orifice control does not develop in the model. This subject will be discussed in more detail in the next section. The agreement between the predicted rating curve and the model results for the case with flow over the ring gate is very good, indeed, up to about 9500 cfs, when the model data show a slightly more efficient performance, but at that flow rate, the reservoir elevation had reached within 1.5 feet of the top of the embankment.

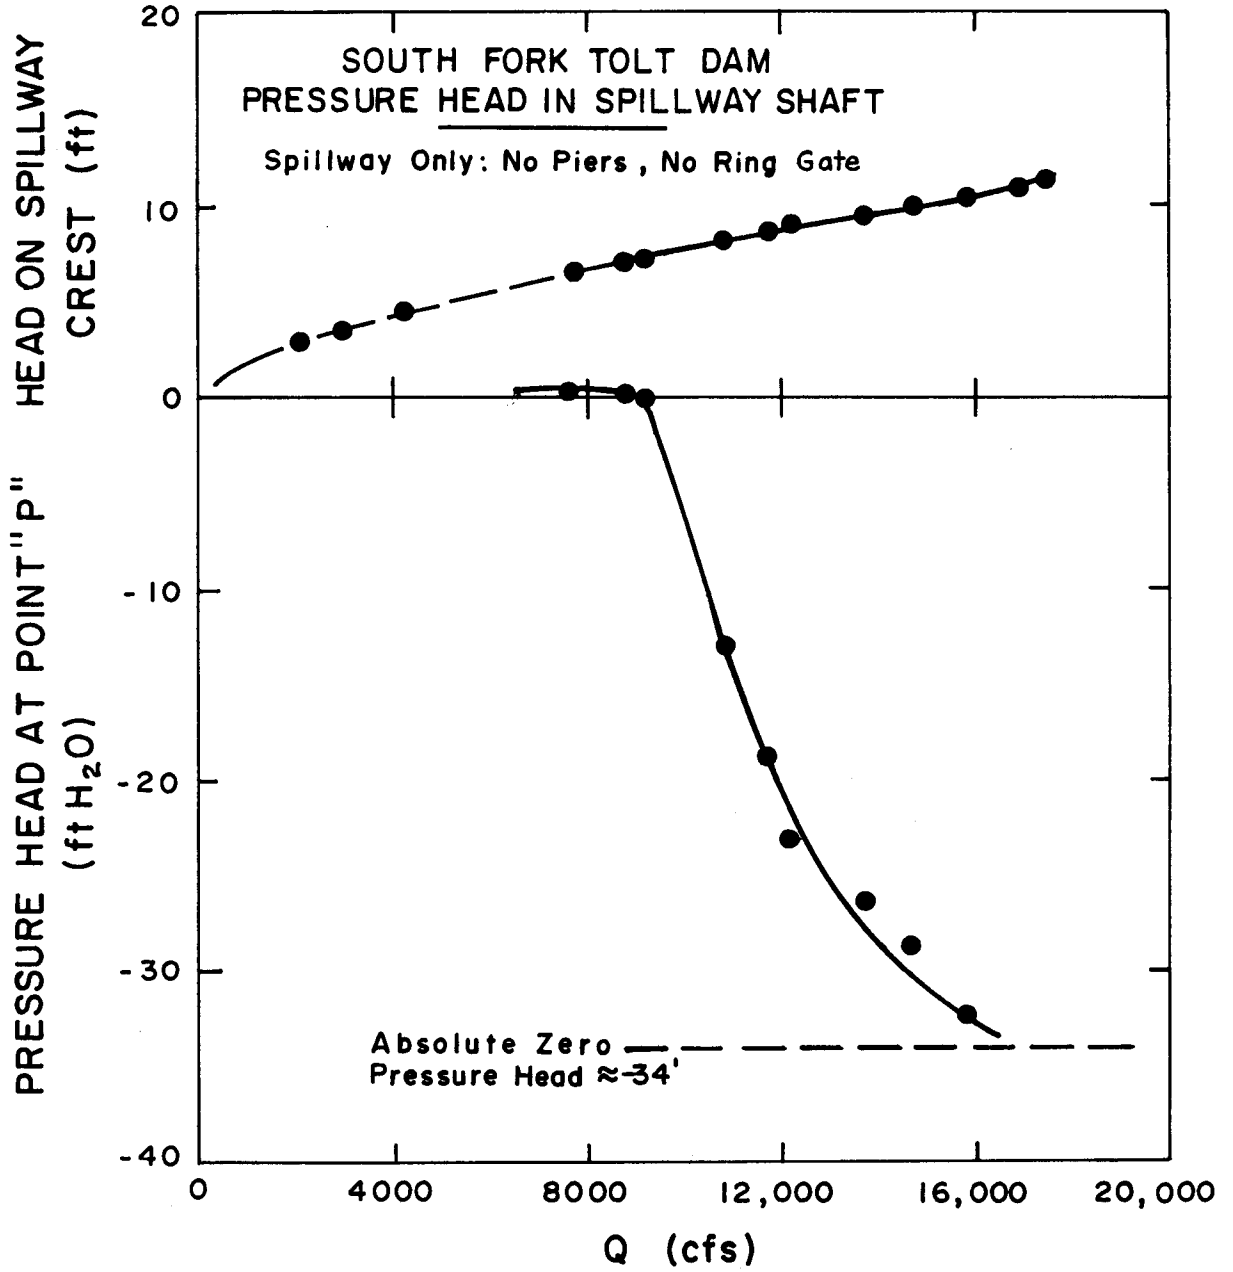
Figure 12. Pressure Head in Spillway Shaft: No Piers

The pressure head at the reference point "P" stays positive for the case without piers up to a flow rate of about 9000 cfs, and up to about 8000 cfs with the piers. Above the 8-9000 cfs rates, the pressure head at "P" begins to be negative and reaches a value of -20 feet at about 12,000 cfs. Hydrodynamic instabilities associated with the low pressures at these high flows could lead to structural vibrations. At the 12,000 cfs flow, a separate critical condition is reached, i.e., the reservoir surface reaches the bottom of the ring gate when in its raised position.
