HYDROLOGIC MONITORING OF THE SEATTLE ULTRA-URBAN STORMWATER MANAGEMENT PROJECTS

Adrienne V. Miller
Stephen J. Burges
Richard R. Horner

Water Resources Series
Technical Report No. 166
April 2001

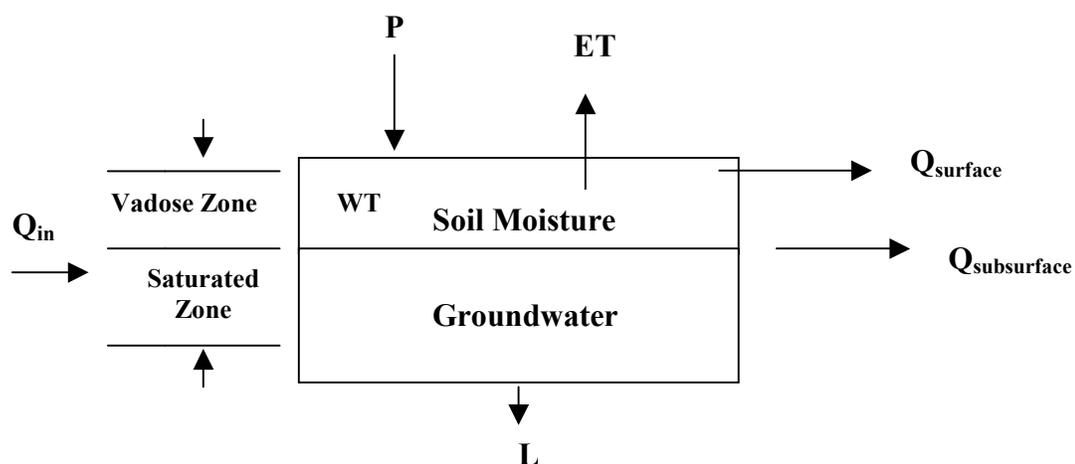
Figure 2-1: The water balance concept

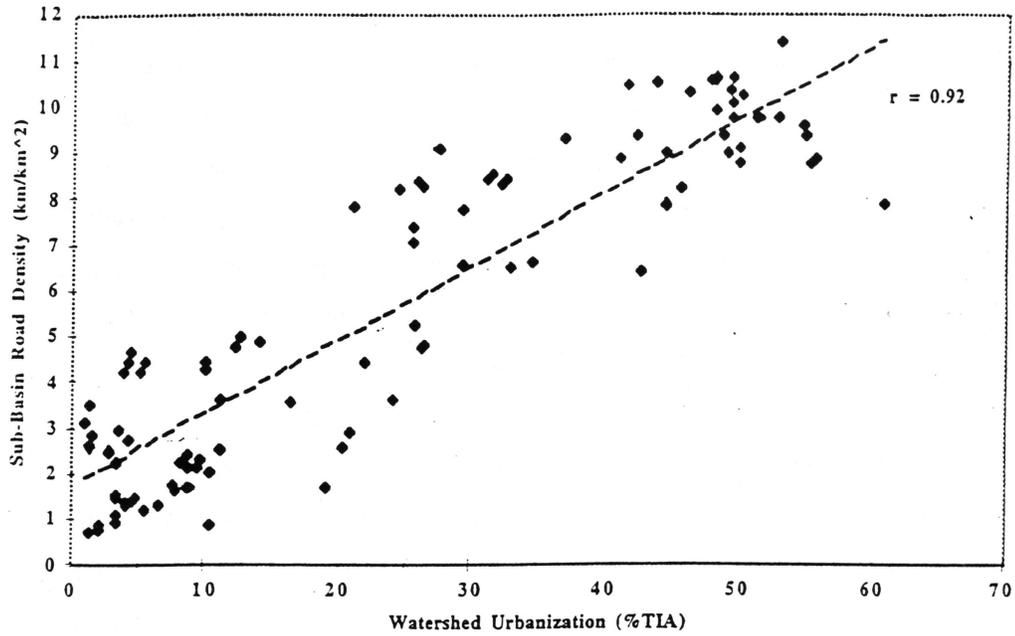
Figure 2-2: Road-density as an index of watershed urbanization (%TIA) in the Puget Sound Lowland Streams (May et al., 1997)

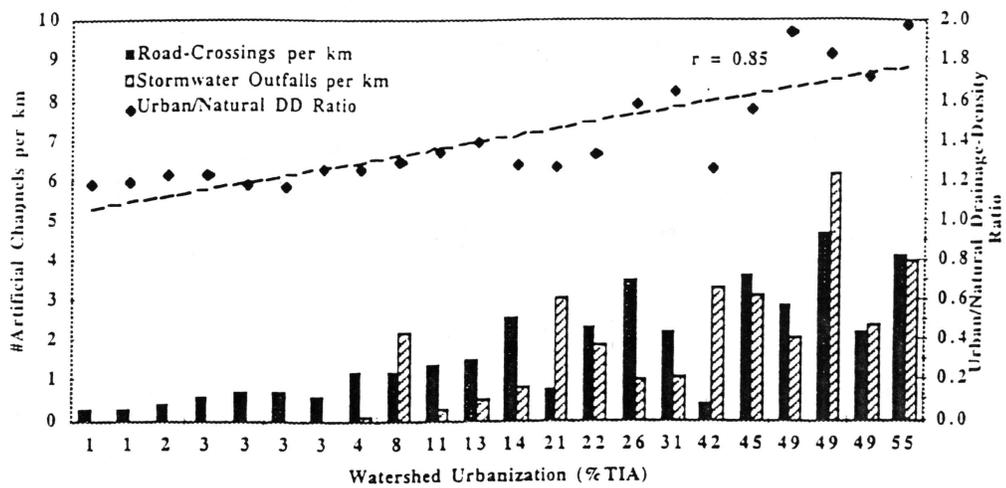
Figure 2-3: Artificial channels and changes in the natural drainage density as an index of watershed urbanization (%TIA) in the Puget Sound Lowland Streams (May et al., 1997)

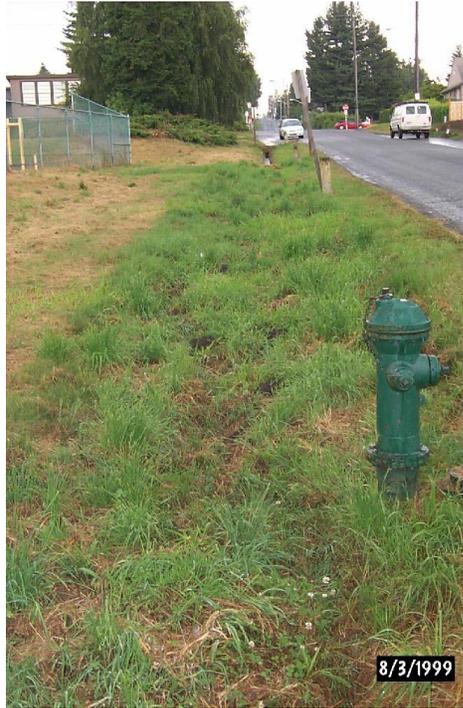
Figure 3-2: Pre-construction at the Viewlands Demonstration Swale site (facing upstream towards NW 105th Street)

Historically, large stormwater flow rates, with an estimated maximum peak flow rate of 25 cfs for a 25-yr 24-hr storm, were discharged at velocities estimated at up to 15 ft/s into a constructed open drainage channel (Figure 3-2). The drainage channel was approximately 175 ft (53.3 m) long and 3 ft to 6 ft (0.9 to 1.8 m) wide. The first 55 ft (16.8 m) section was an open concrete channel, and the last 120 ft (36.6 m) section was a vegetated ditch. After stormwater passed through the channel, it entered a grated drain inlet box and was tight-lined down a steep bank to Pipers Creek.

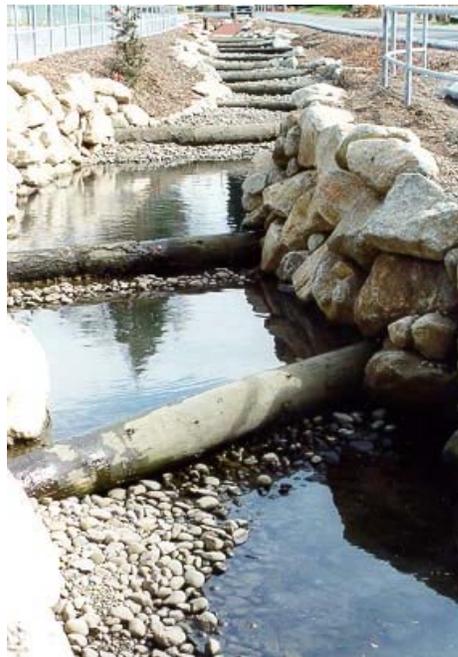
Figure 3-3: Post-construction at the Viewlands Demonstration Swale site (facing upstream towards NW 105th Street)

The new Viewlands Demonstration Swale is not a vegetated swale design. Instead, the channel was designed to simulate key components of a natural gravel-bed stream reach, aimed at mitigating the impacts of stormwater on urban waterways. The physical constraints of the site, particularly the limited available land area, precluded inclusion of an artificial flood plain or extended storage basin. Figures 3-2 and 3-3 compare the Viewlands site in the pre-construction phase as a vegetated swale and in the post-construction phase, as a swale that simulates a natural stream reach.

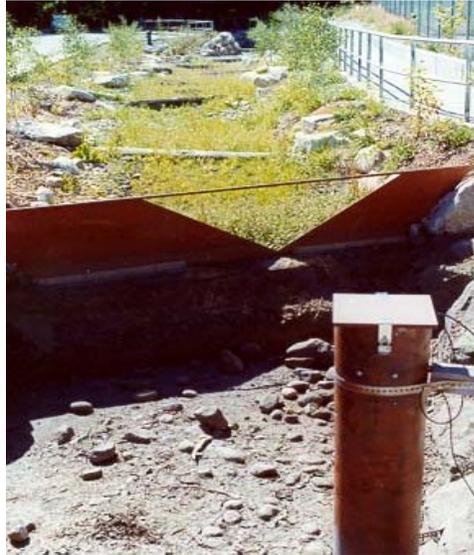
Figure 3-4: View of Cell 1 that includes the stand pipe housing the flow monitoring equipment and a 120° V-notch weir (facing downstream towards Pipers Creek)

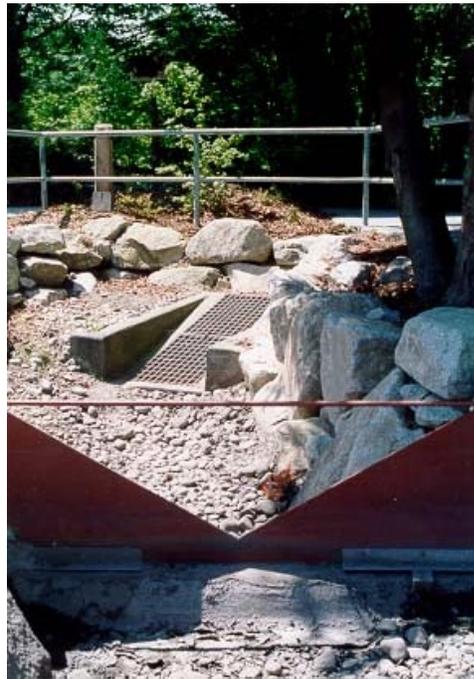
Figure 3-5: View of Cell 16 that includes a 120° V-notch weir and the concrete culvert with metal grating (facing downstream towards Pipers Creek)

The water eventually reaches Cell 15, which is immediately upstream of the second 120° V-notch weir (Figure 3-5). Cell 15 is sized to form a level quiescent pool and the water level is recorded by monitoring equipment housed in a stand pipe. The water that flows over the V-notch weir falls into a rock-armored plunge pool (in Cell 16) and into the grated metal concrete culvert. Once in the concrete pipe, the water flows through an energy dissipation structure and to the natural stream system of Pipers Creek.

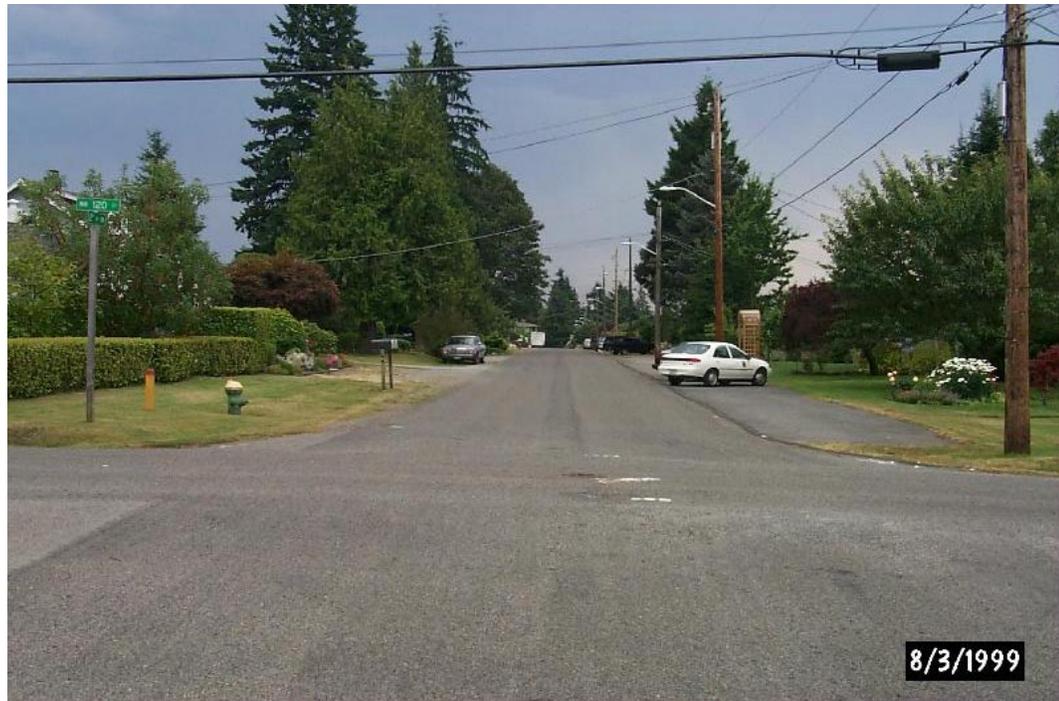
Figure 3-6: The pre-construction site at the 2nd Ave SEA Streets Project (view south-facing 2nd Ave NW from NW 120th St)

The chosen location for the Street Edge Alternatives (SEA) Streets Project is the residential block of 2nd Avenue NW, between NW 117th and 120th Streets. Refer to Figure 3-6 for a view of the 2nd Avenue street at pre-construction in August 1999.

The project area slopes slightly toward the southwest (Figure 3-6). Runoff flows parallel to a low asphalt berm along the full length of the west side of 2nd Ave NW. It discharges flow to a ditch along the north side of NW 117th at the corner of 2nd Ave NW, which is part of the conveyance system that eventually reaches Pipers Creek (Figure 3-7). Properties on the east side of 2nd NW have substantial pervious yard and contribute less runoff than direct precipitation on the right-of-way. Properties on the west side of the block mainly drain away from the street and contribute little street runoff.

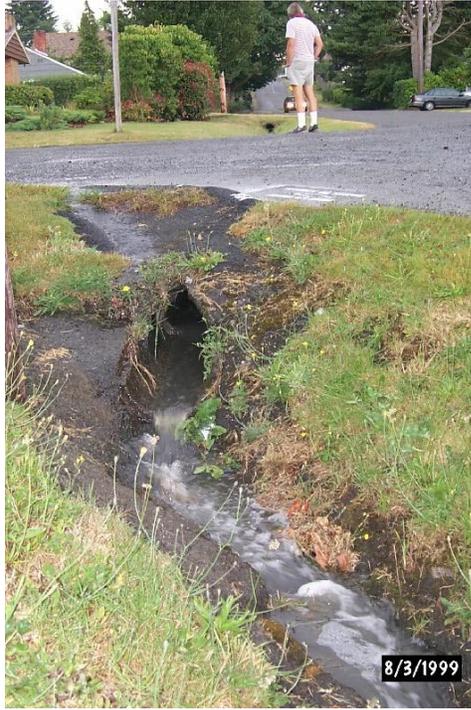
Figure 3-7: The pre-construction outflow location (at 2nd Ave NW facing east on NW 117th St)

To prepare for baseline monitoring, the project area was isolated hydraulically by placing two traffic speed bumps across the entrances of 2nd Ave NW at NW 117th and another at NW 120th Street. Water flow from the isolated part of the street was directed towards a constructed monitoring station, placed on the southwest corner of 2nd Ave NW and NW 117th Street. Figures 3-7 and 3-8 show the location of the monitoring station before and after construction. The flow monitoring station consisted of a concrete vault covered by a geosynthetic liner that formed a leak-proof stilling basin, a stand pipe that housed the flow monitoring equipment, and a 22.5° V-notch weir. The weir outflow was then directed to the open channel near the pipe underneath 2nd Avenue (Figure 3-7).

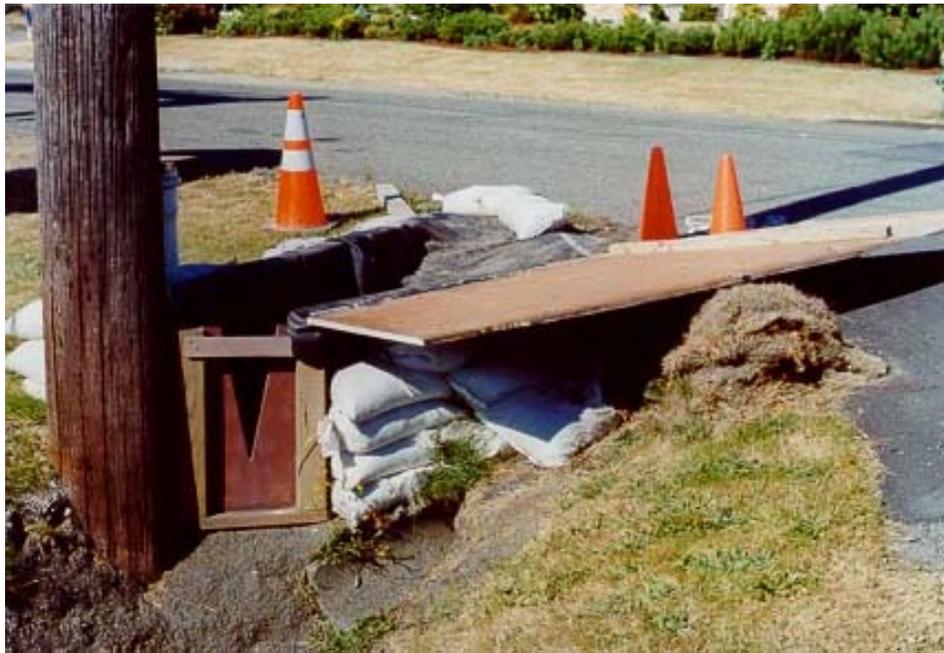
Figure 3-8: The pre-construction location for the V-notch weir and runoff measurement system (at 2nd Ave NW facing east on NW 117th St)

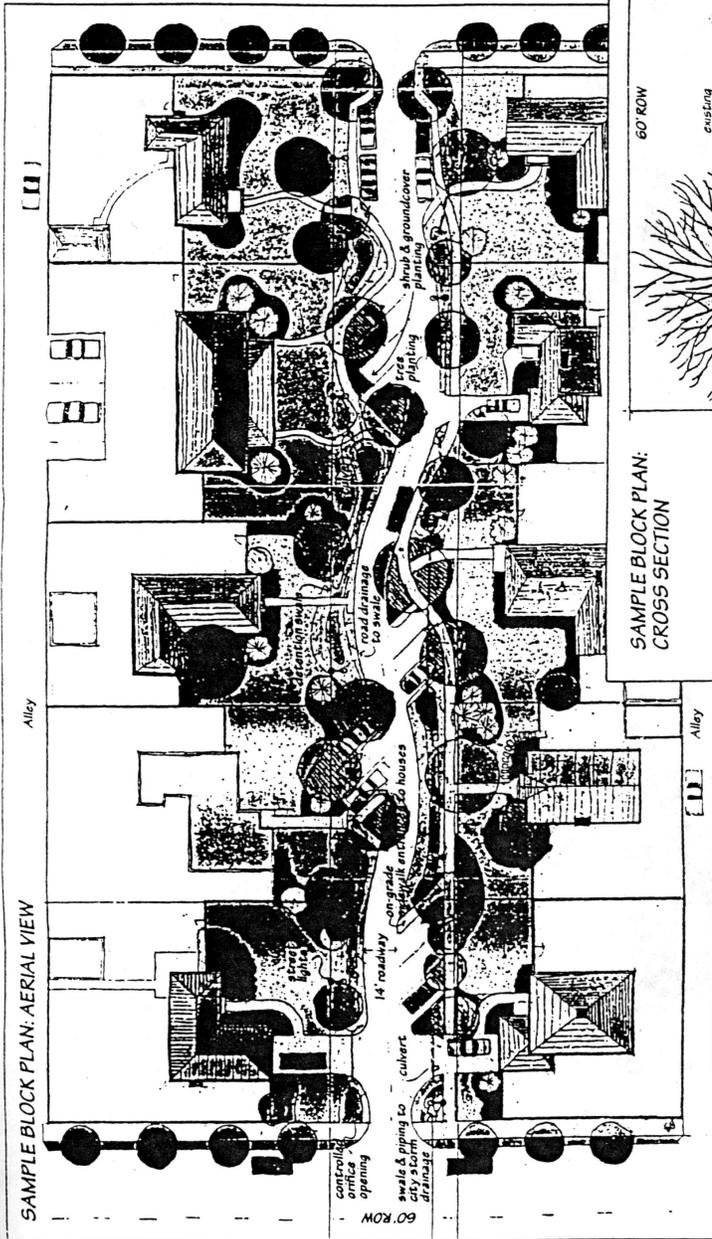
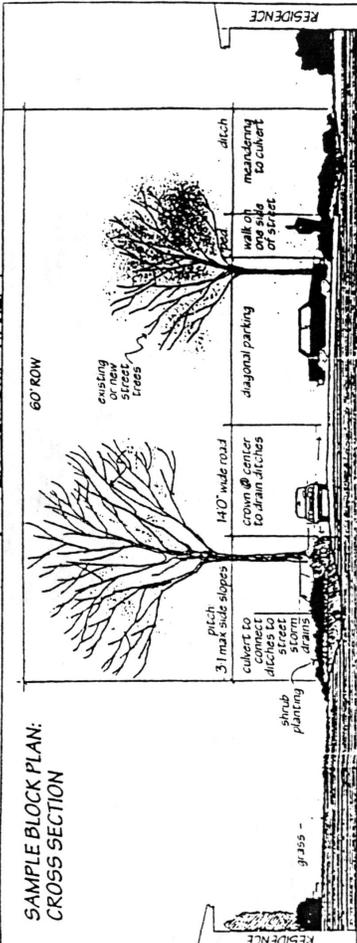
Figure 3-10: The SEA Streets project block plan

STREET EDGE ALTERNATIVES
 City of Seattle/Seattle Public Utilities January 19, 1999
 Drawing prepared by Springwood Assoc. Revised March 28, 1999

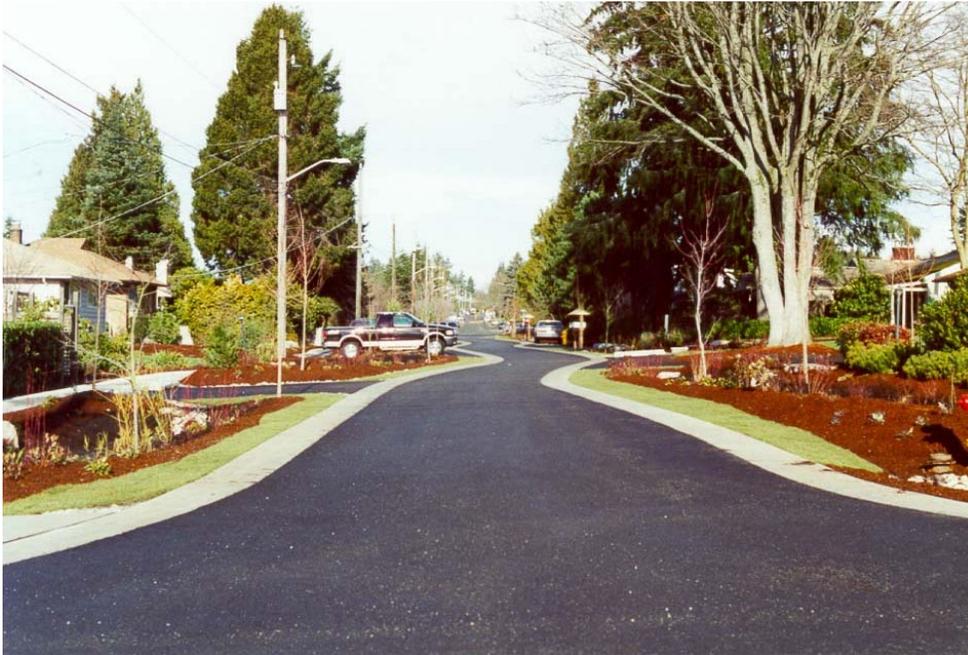
Figure 3-10: The post-construction site at the SEA Streets Project (view north-facing 2nd Ave NW from NW 117th St)

Initial construction began on July 24, 2000, but was delayed while the design was modified. Work restarted on September 25, 2000 and continued through January 12, 2001. Post-construction monitoring began on January 19, 2001. The as-built project is shown in schematic plan form in Figure 3-9 and pictorially in Figure 3-10.

As part of the street redesign, the street width was decreased by approximately 6 ft (1.8 m) and parking was reduced and set perpendicular to the street (Figure 3-10). The sidewalks are approximately 5 ft (1.5 m) in width. Both the street and sidewalks meander along the length of the block, following the contours of the detention ponds. Detention ponds have been constructed in front of the residences, with a system of culverts that connect the ponds to the monitoring swale (Figure 3-11). The detention ponds are approximately 15 ft (4.6m) in width, 50 to 75ft (15 to 25m) in length, and are planted with native landscaping (Seattle Public Utilities 1999).

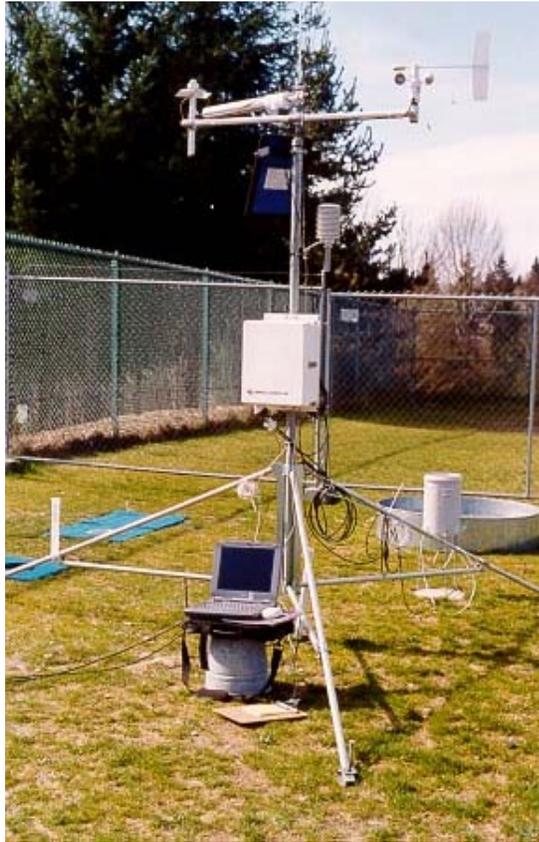
Figure 4-1: The CM10 Tripod Weather Station located at the Viewlands swale monitoring station

The tasks involved in setting up the CM10 Tripod Weather Station were mounting and wiring both the CR10X Data logger and PS12LA 12V Power Supply PS12LA 12V Power Supply. The HMP45C Temperature and Relative Humidity Probe, Met One 034A-L Windset Wind Anemometers, and Kipp & Zonen CM3 Shortwave Pyranometer were also attached to the tripod, wired, and programmed. The tripod was grounded for lightning strike protection.

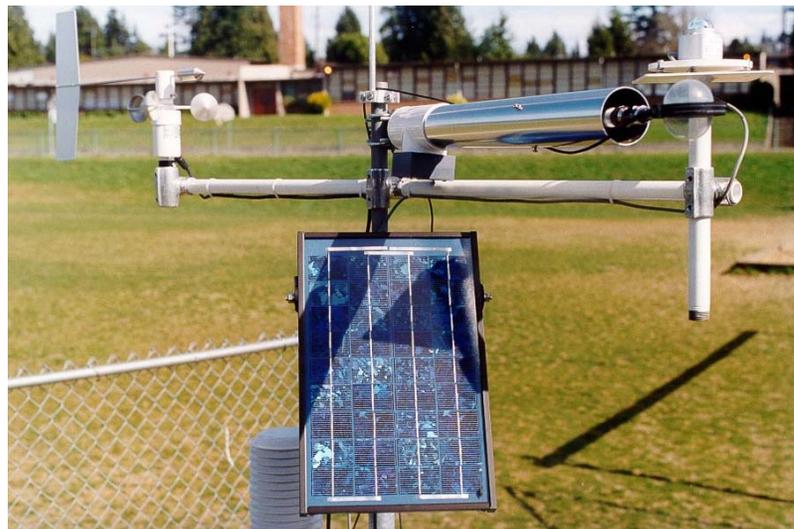
Figure 4-2: The CM10 Tripod Weather Station with a mounted solar panel, wind anemometer, net radiometer, and shortwave pyranometer. Two additional Campbell Scientific CR10X data loggers are located within the fenced meteorological station. They collect and store information from the pressure transducers and shaft encoders in the swale and in the evaporation pan collection system (Figure 4-3). The data loggers are mounted 5 ft (1.5 m) from the ground on 1.5 in (3.8 cm) diameter galvanized steel pipes set in concrete. A 12-volt marine rechargeable battery powers the instruments.

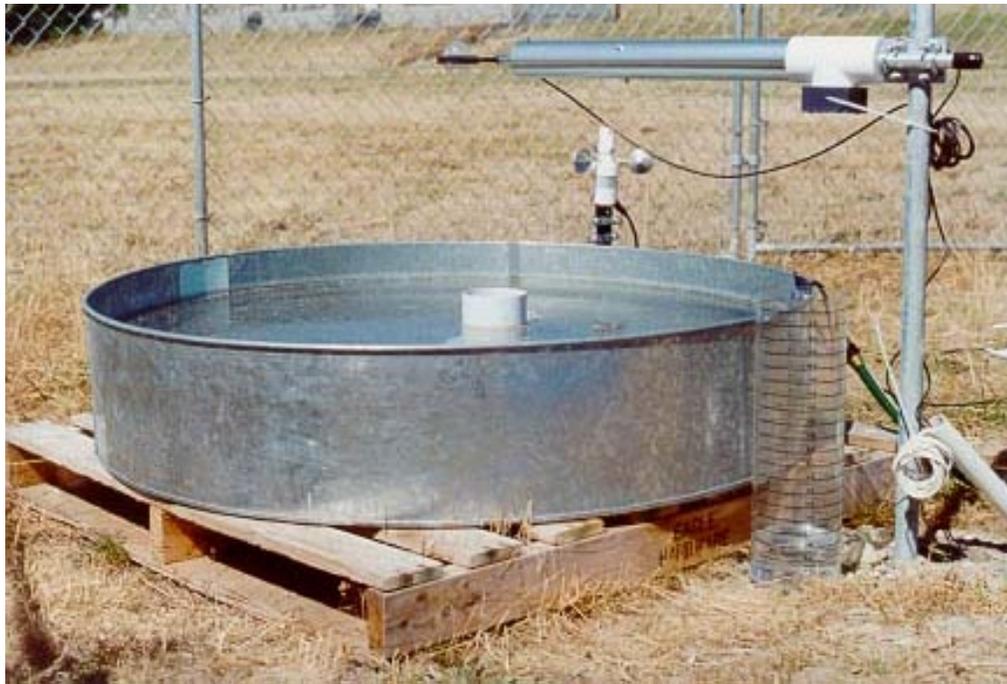
Figure 4-3: The evaporation pan collection system

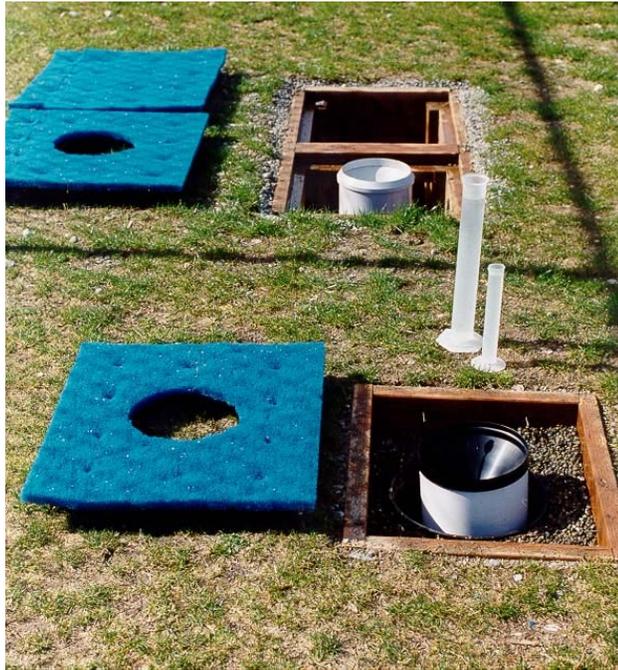
Figure 4-4: The buried TB3 tipping-bucket trench gauge (top) and the buried Novalynx gauge (bottom)

prevents splash of water into the gauge. Figure 4-4 shows the buried TB3 trench gauge (top) and the buried Novalynx precipitation gauge (bottom) within the station.

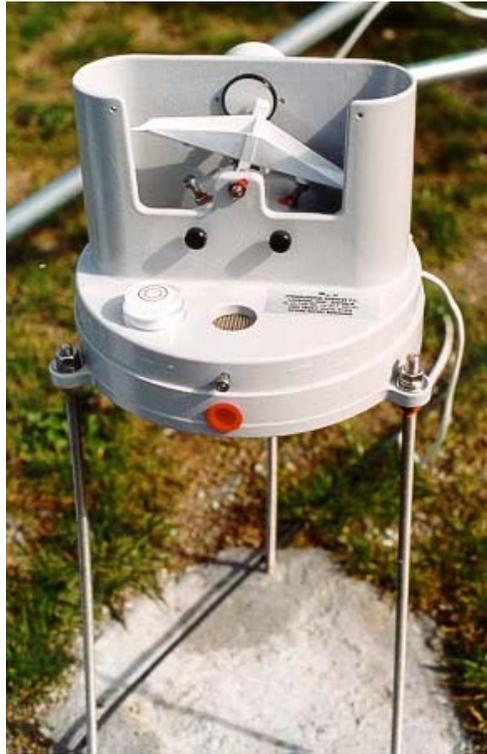
Figure 4-5: The standing TB3 tipping bucket gauge

The standing TB3 precipitation gauge is mounted on three stainless steel threaded rods with the gauge placed 25 in (63.5 cm) above the ground (Figure 4-5). Standing precipitation gauges are the most common configuration used to collect precipitation, but they underestimate the amount of precipitation due to wind flow patterns. A wind anemometer is placed at the height of the lip of the gauge to measure the wind speed to attempt to correct the recorded precipitation.

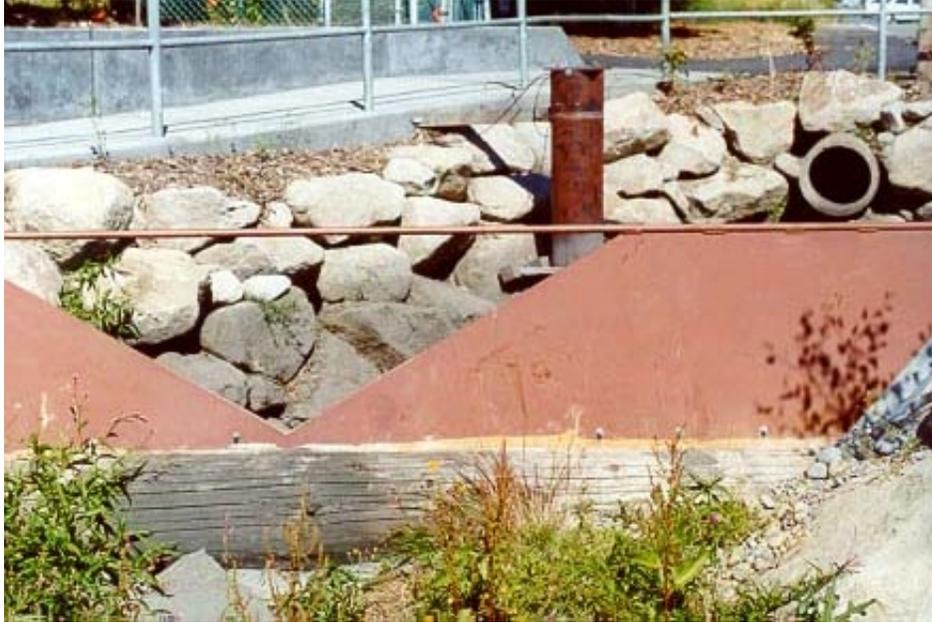
Figure 4-6: The upstream V-notch weir, standpipe, and influent pipe (facing upstream towards NW 105th Street)

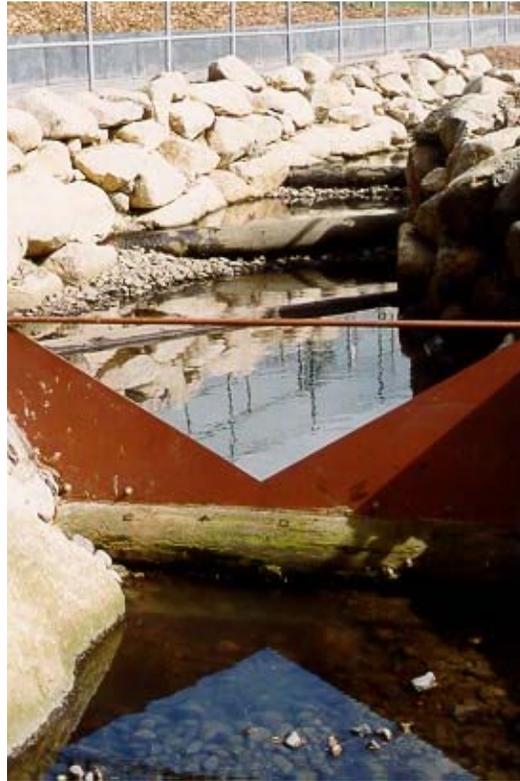
Figure 4-7: The downstream V-notch weir with Cells 15 and 16 filled (facing upstream towards NW 105th Street)

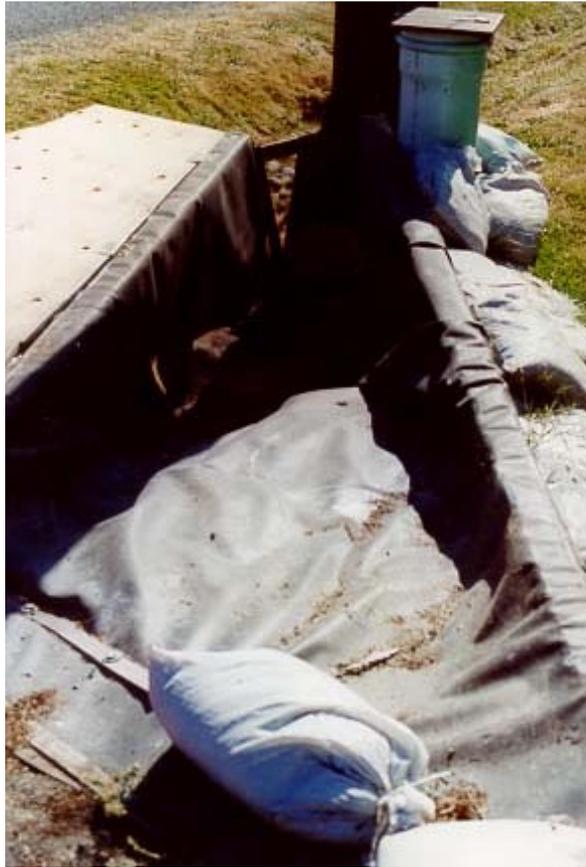
Figure 4-8: The constructed stilling basin and stand pipe housing the shaft encoder at the SEA Streets site

Flow from the street was directed towards an at-grade or near-grade concrete vault, covered by a geosynthetic liner that formed the leak-proof stilling basin (Figure 4-8). A geosynthetic liner was placed between the asphalt road and outlet of the weir to prevent any infiltration or leakage of water from the stilling basin. The sides of the stilling basin were buttressed by sandbags to create a storage volume of approximately 4.5 ft³ (0.13 m³). The stilling basin was covered by a lid made from plywood for safety and protection.

A stand pipe was located next to the stilling basin. The stand pipe provided protection of the flow monitoring equipment and dampened waves as water flowed into the stilling basin. A CS410 shaft encoder was housed in the standpipe to measure the water level. The reference point was established as the bottom of the stand pipe and the relationship between the invert of the weir and the reference point was determined by surveying.

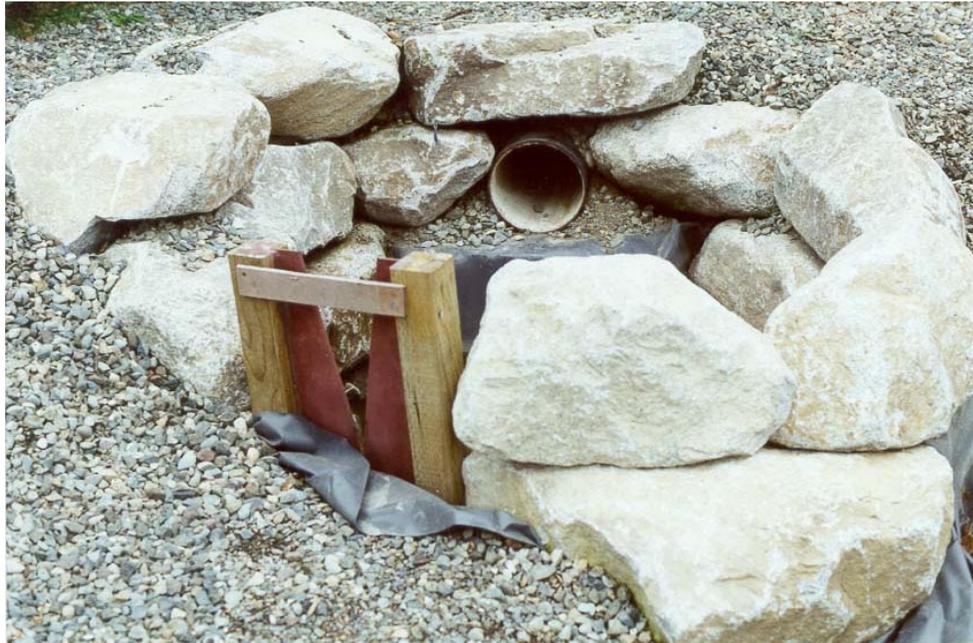
Figure 4-9: Construction of the new monitoring stilling basin at the SEA Streets site

stilling basin. The new standpipe is placed within the stilling basin and houses the shaft encoder. Figure 4-9 shows the new basin located at SEA Streets during construction.

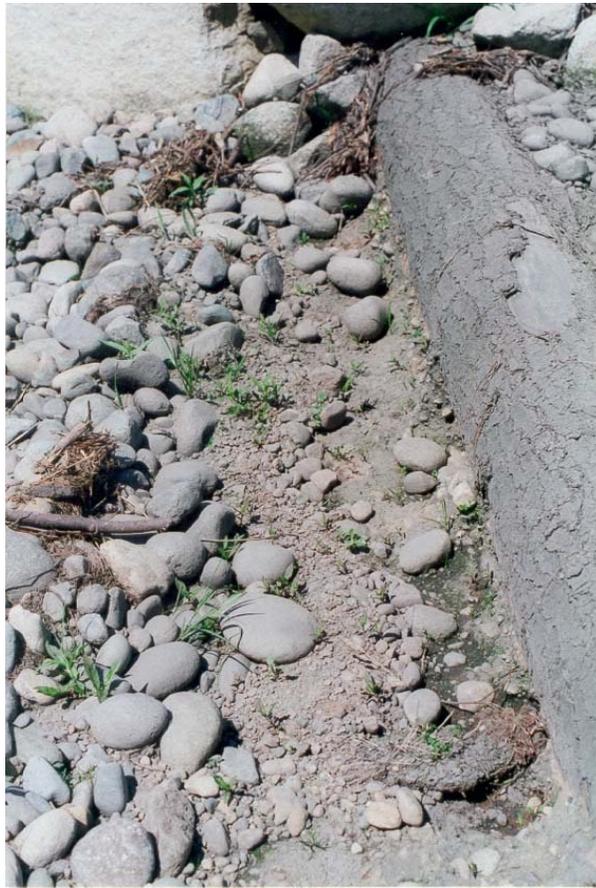
Figure 6-1: Scouring downstream of each log weir from 6 to 8 in (15.2 to 20.3 cm)

of each log migrated approximately 6 to 12 in (15 to 31 cm) (Figure 6-1). Scour pools formed beneath the invert of the weir plate due to the concentrated flow, eroding the channel bed to maximum depth of 6 to 8 in (15 to 20 cm). In addition, the geotextile that was placed between the concrete bed of the first cell and the log weir to prevent leakage deteriorated over time. The undercutting of the log weirs and the environmental deterioration of the geotextile led to leakage under and around the stilling basins in Cells 1 and 15.

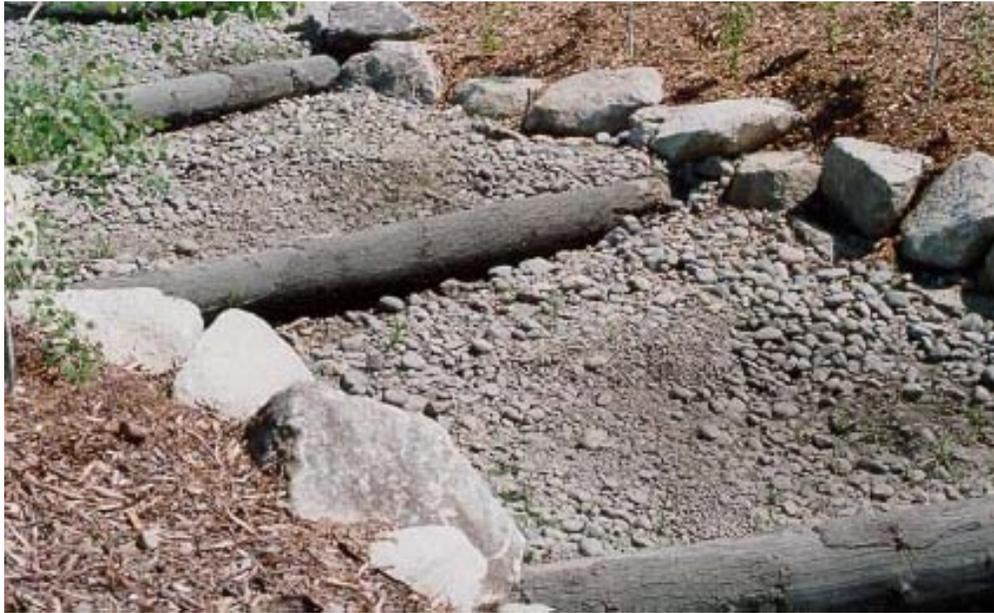
Figure 6-2: Typical bed cross-section for the constructed Viewlands swale

The first step in the pre-construction analysis was to determine the potential infiltration area in the new swale. The new swale was designed to accommodate low flow through the center of the channel and high flow over the entire width of the channel bed. Figure 6-2 shows a photograph of the typical bed cross-section for one cell in the swale. The bed slope is 0.048 and the Manning’s roughness coefficient (n) is 0.04, for a constructed rock-lined channel with some weeds (King County Surface Water Design Manual, 1998). The low flow bed width is 7 ft (2.1 m), with a 1:1 side slope that produces a depth of 0.9 ft (0.27 m) and accommodates a maximum low flow rate at 48 cfs (1,359 L/s). The high flow bed width is approximately 11 ft (3.4 m) with a minimum boulder height of 1.7 ft (0.52 m) defining the high flow depth.

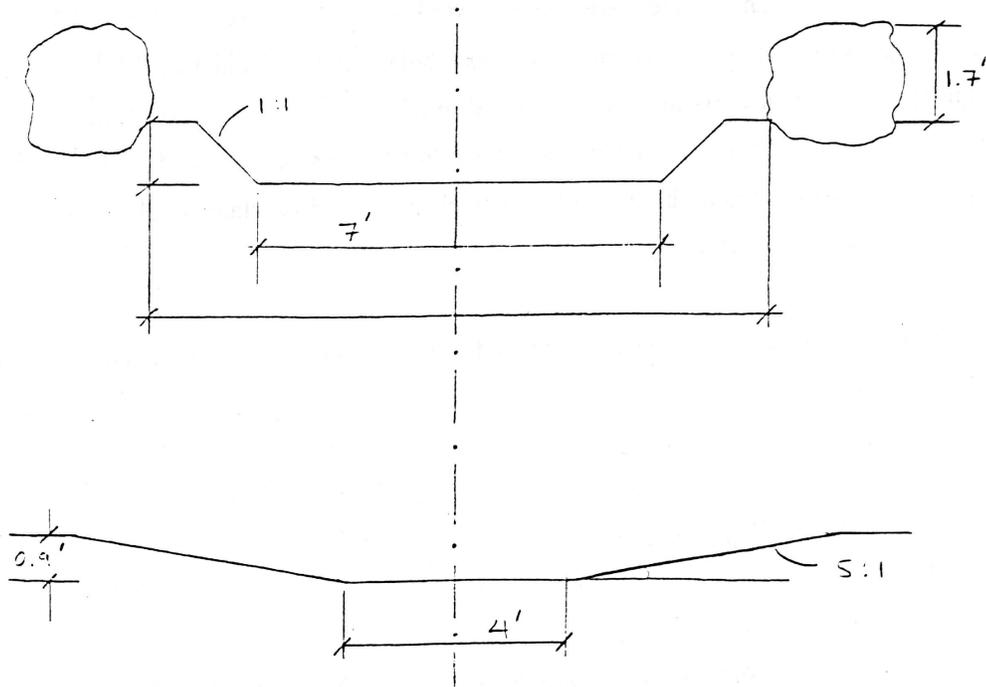
Figure 6-3: The channel cross-sections for the new swale (top diagram) and for the vegetated section of the old channel (bottom)

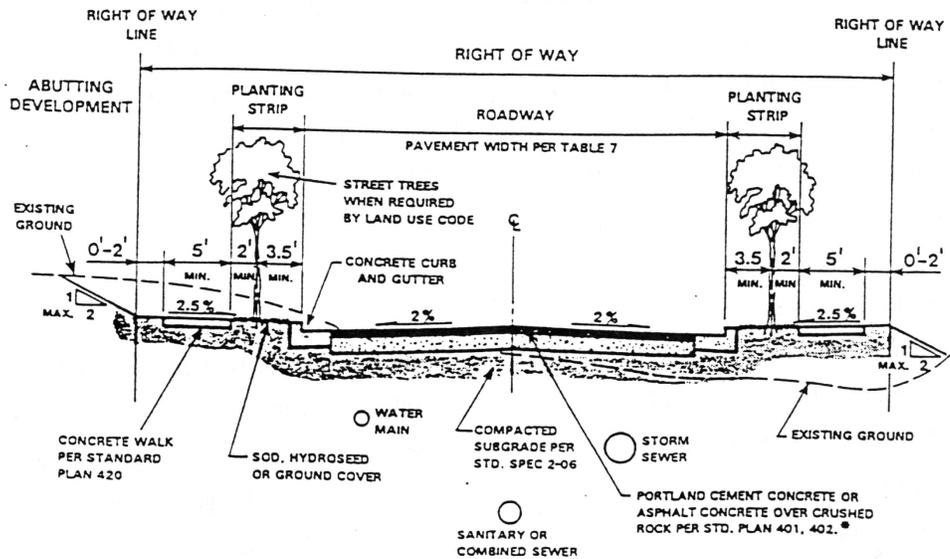
Figure 6-4: Minimum dimensions for a conventional street design

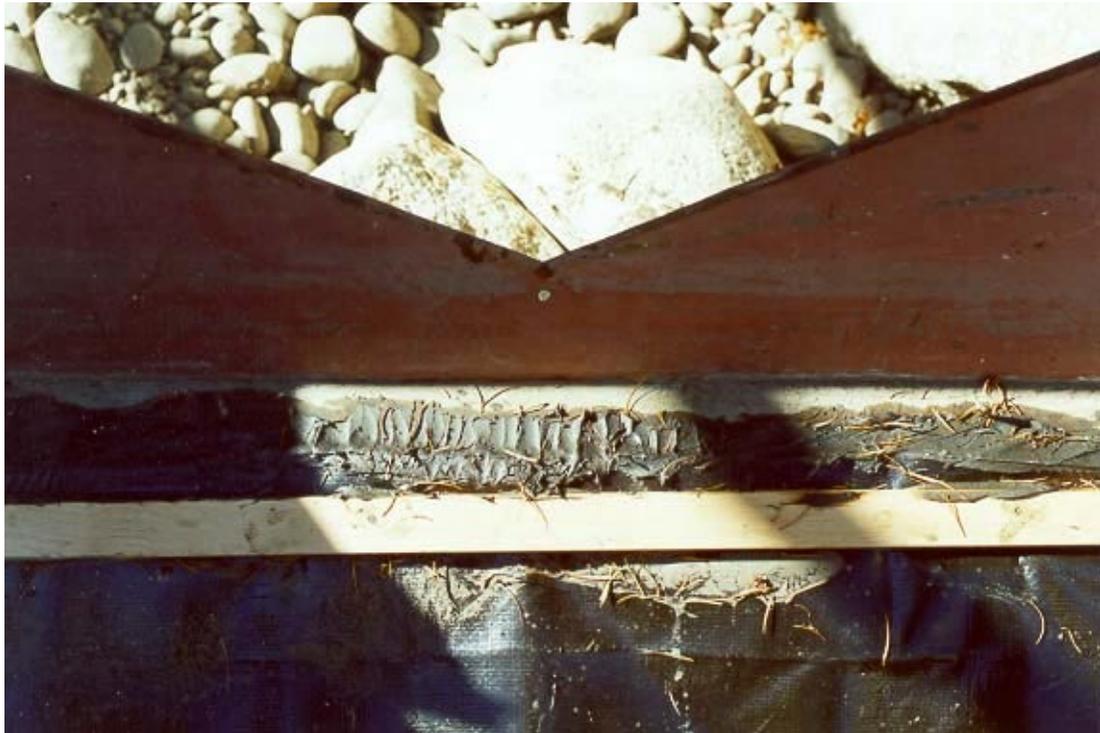
Figure 7-1: Environmental deterioration and geometric constraints of the V-notch weir

V-notch weirs are designed, tested, and calibrated in the laboratory setting with a vertical upstream face flush with a bulkhead. At the Viewland site, the bottom of the weir plate is not flush with the log weir but is mounted onto its top middle section. In addition, the invert of the upstream weir is 2.4 in (6.1 cm) from the base of the weir plate, and the invert of the downstream weir is 4.9 in (12.4 cm) from the base. The maximum upstream head observed to date has been 11.5 in (29.2 cm). As discussed in Chapter 2, 23 in (58.4 cm) should be the minimum distance from the invert to the weir plate, not 2.4 in. Figure 7-1 shows the environmental deterioration of the V-notch weir plate and improper placement on the log weir that resulted from site geometric constraints.

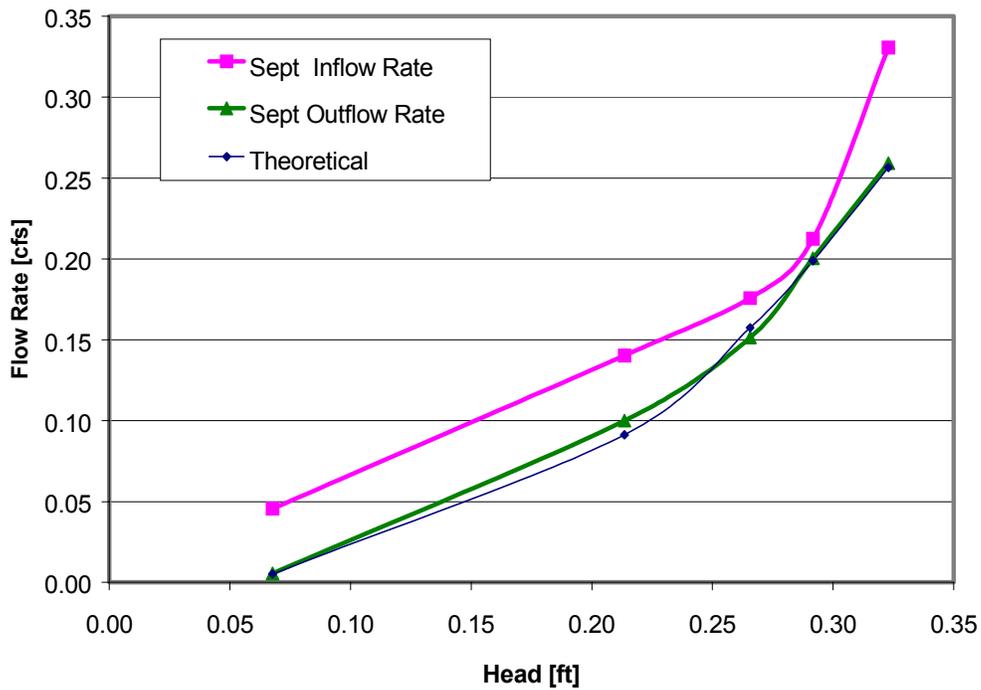
Figure 7-2: September 2000 tests – measure of the inflow rates to and from the upstream V-notch weir

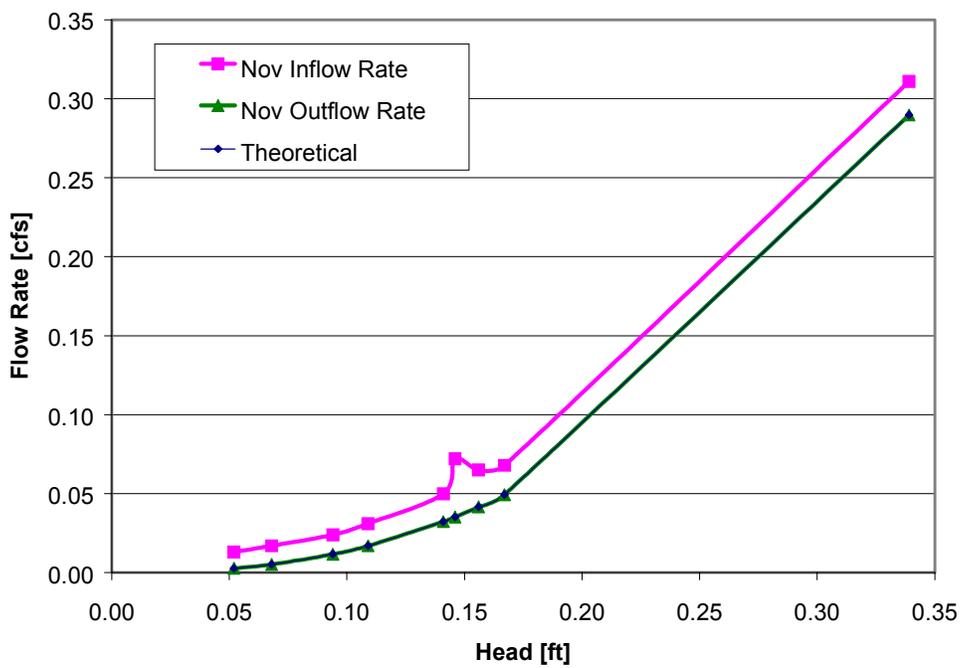
Figure 7-3: November 2000 tests – measure of the inflow rates to and from the upstream V-notch weir

A second set of tests at both weirs confirmed that leakage still occurred but to a lesser degree. The most significant leakage occurred at flow rates less than 0.1 cfs (2.8 L/s). At the upstream weir, low flows of approximately 0.05 cfs (1.4 L/s) exhibited a 36 percent loss of inflow. The loss dropped to 7 percent at flows of approximately 0.3 cfs (8.5 L/s). Figure 7-3 shows the results of the November 2000 test for the upstream V-notch weir. Comparison of Figures 7-2 and 7-3, plotted using the same scale and over the same interval, shows the decrease in leakage between the two upstream weir tests. The downstream weir tests were conducted at flow rates greater than 0.1 cfs (2.8 L/s), so leakage rates of less than 10% occurred.

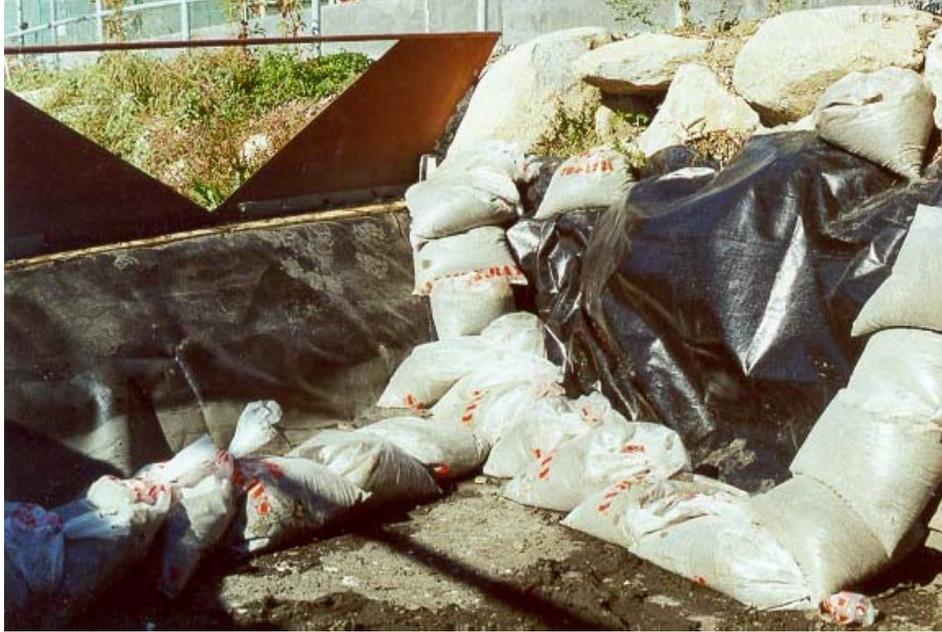
Figure 7-4: Remedial measures taken in October 2000 at the upstream V-notch weir

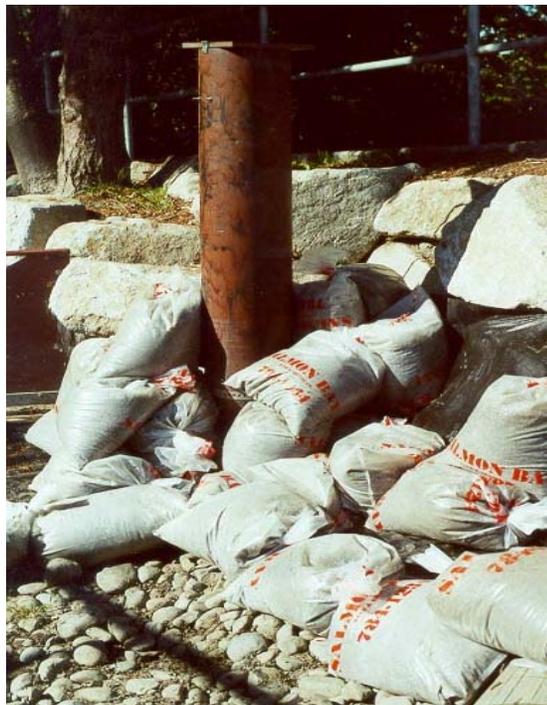
Figure 7-5: Remedial measures taken in October 2000 at the downstream V-notch weir

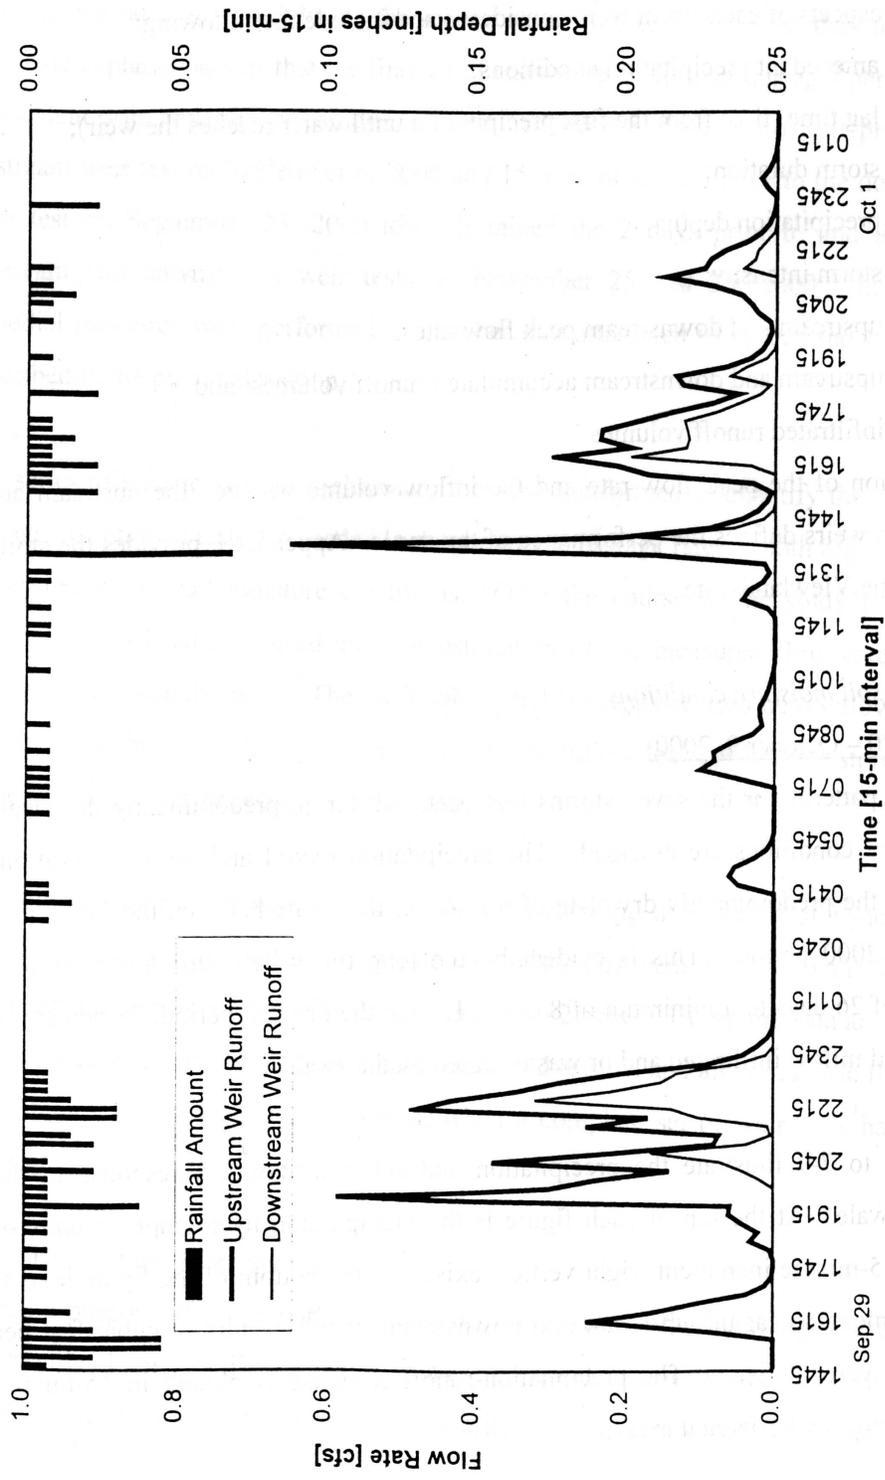
Figure 7-6: Precipitation hyetograph and runoff hydrograph for the Viewlands swale
 September 29 (2:45 pm) - October 1, 2000 (1:45 am)

Figures 7-6 to 7-9 illustrate the precipitation and subsequent runoff response in the Viewland swale. At the top of each figure is the precipitation hyetograph in units of inches per 15-minute increment (right vertical axis). At the bottom of the figure is total runoff rate measured at the upstream and downstream weirs in units of cubic feet per second (left vertical axis). The precipitation-runoff response is plotted in 15-minute increments (bottom horizontal axis).

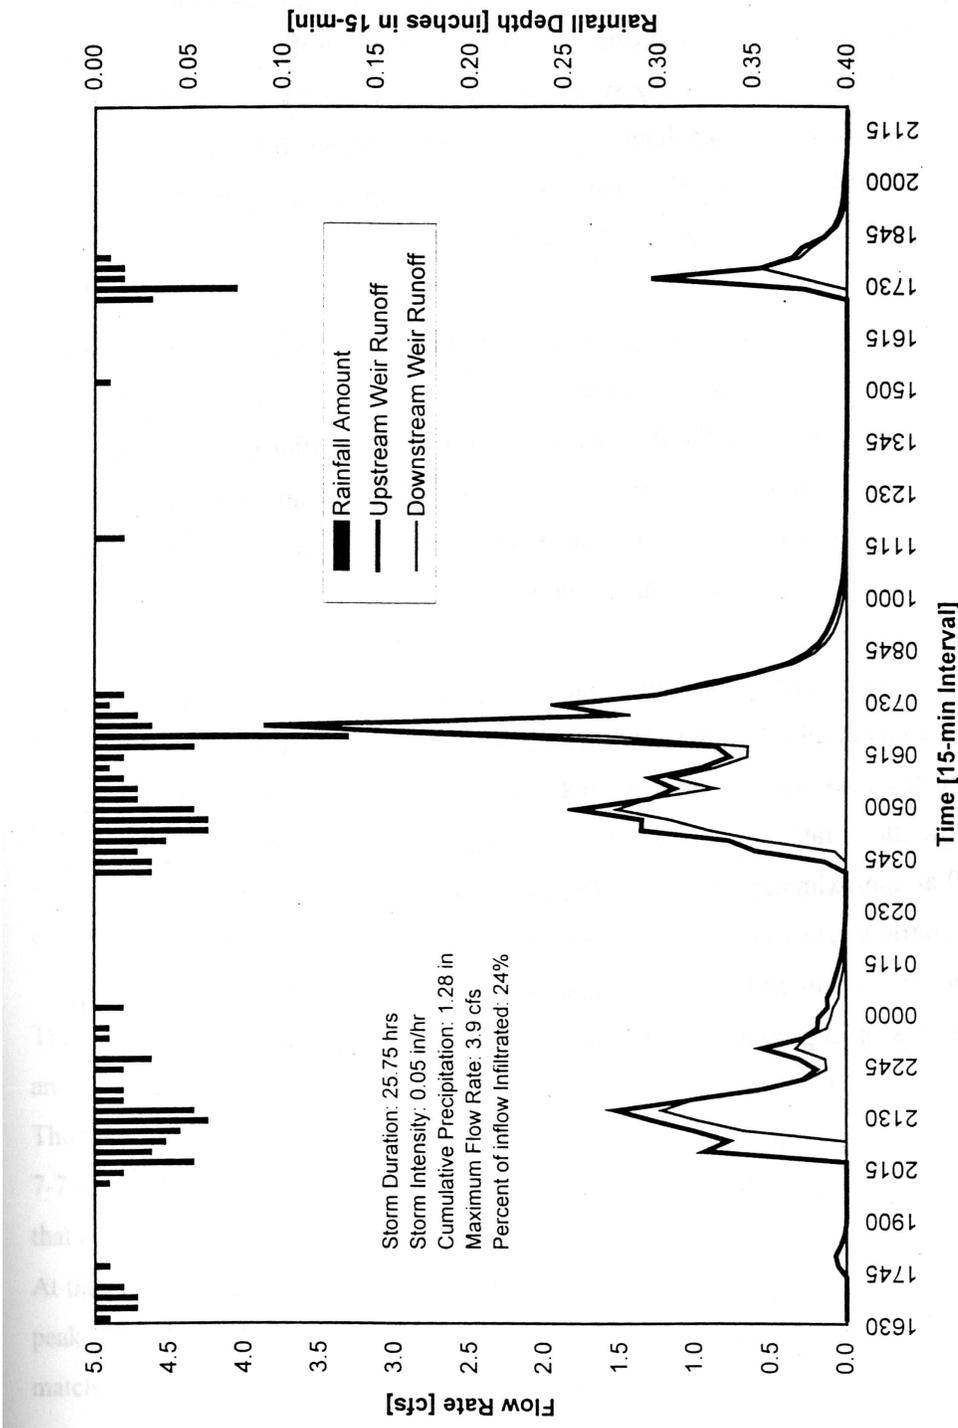
Figure 7-7: Highest-ranked precipitation and runoff for the Viewlands swale
 October 19, 2000 (4:30 pm) - October 20, 2000 (9:30 pm)
