HYDROLOGIC MONITORING OF THE SEATTLE ULTRA-URBAN STORMWATER MANAGEMENT PROJECTS

Adrienne V. Miller
Stephen J. Burges
Richard R. Horner

Water Resources Series
Technical Report No. 166
April 2001

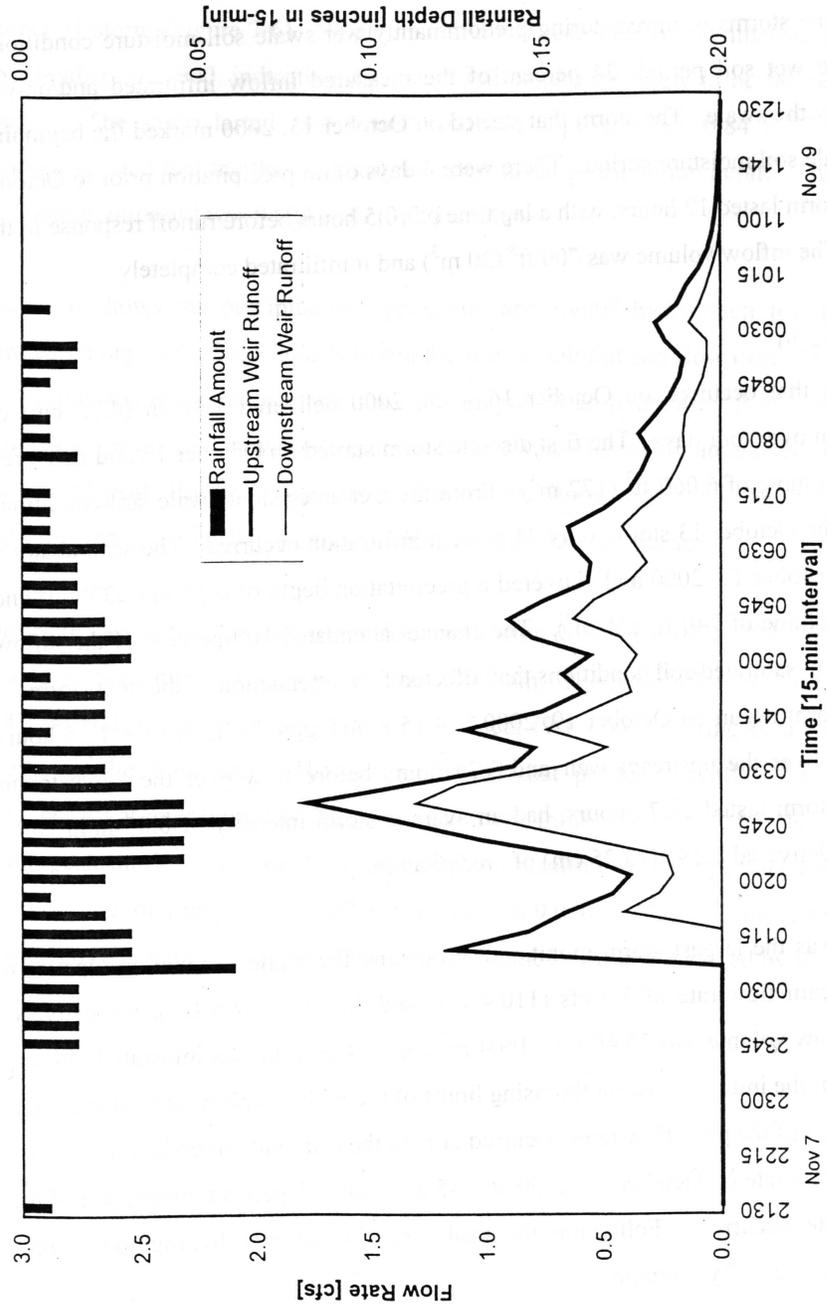
Figure 7-8: Precipitation hyetograph and runoff hydrograph for the Viewlands swale
 November 7, 2000 (9:30 pm) - November 9, 2000 (12:30 pm)

Figures 7-6 to 7-9 illustrate the precipitation and subsequent runoff response in the Viewland swale. At the top of each figure is the precipitation hyetograph in units of inches per 15-minute increment (right vertical axis). At the bottom of the figure is total runoff rate measured at the upstream and downstream weirs in units of cubic feet per second (left vertical axis). The precipitation-runoff response is plotted in 15-minute increments (bottom horizontal axis).

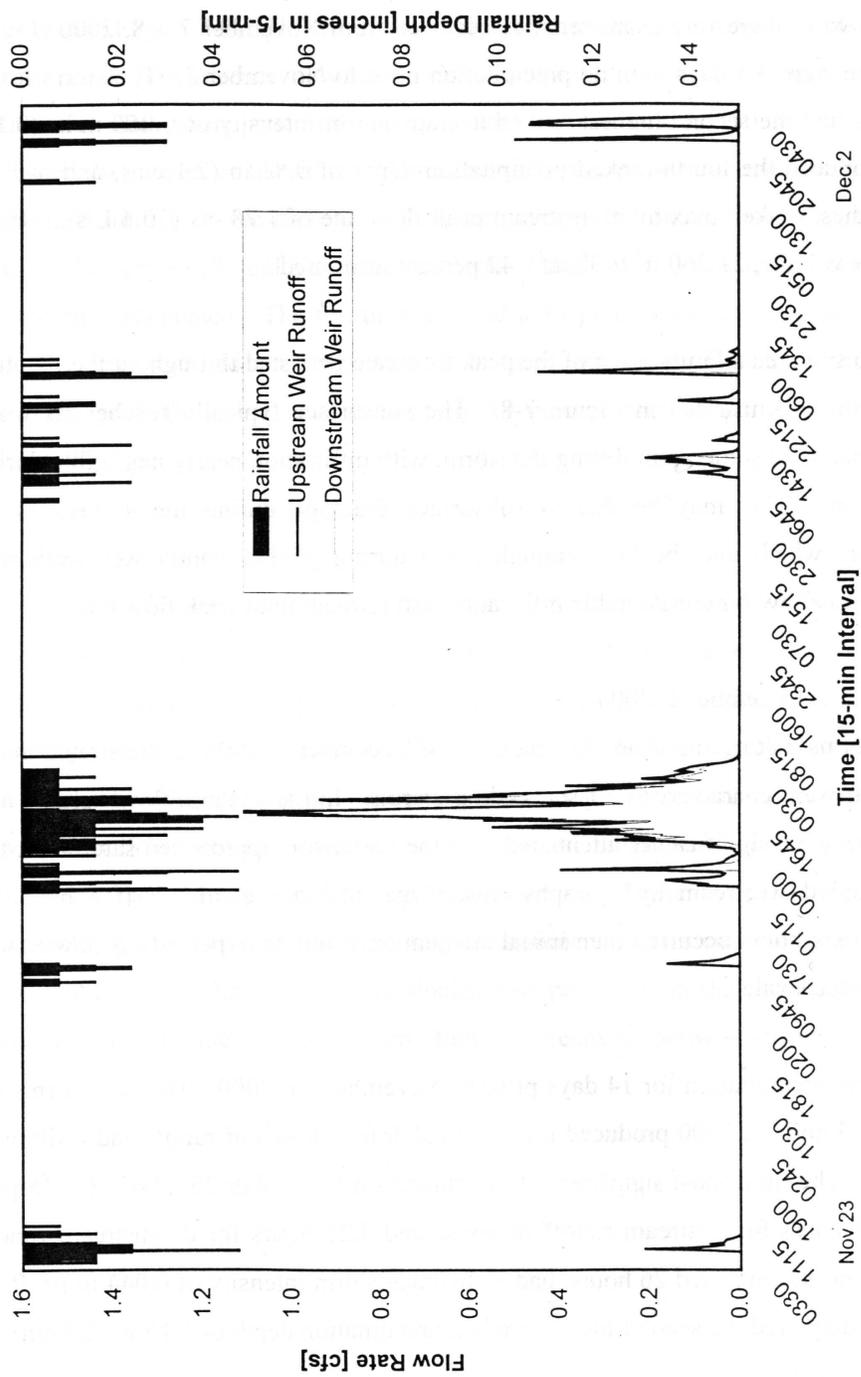
Figure 7-9: Precipitation hyetograph and runoff hydrograph for the Viewlands swale
 November 23, 2000 (3:30 am) - December 2, 2000 (3:30 am)

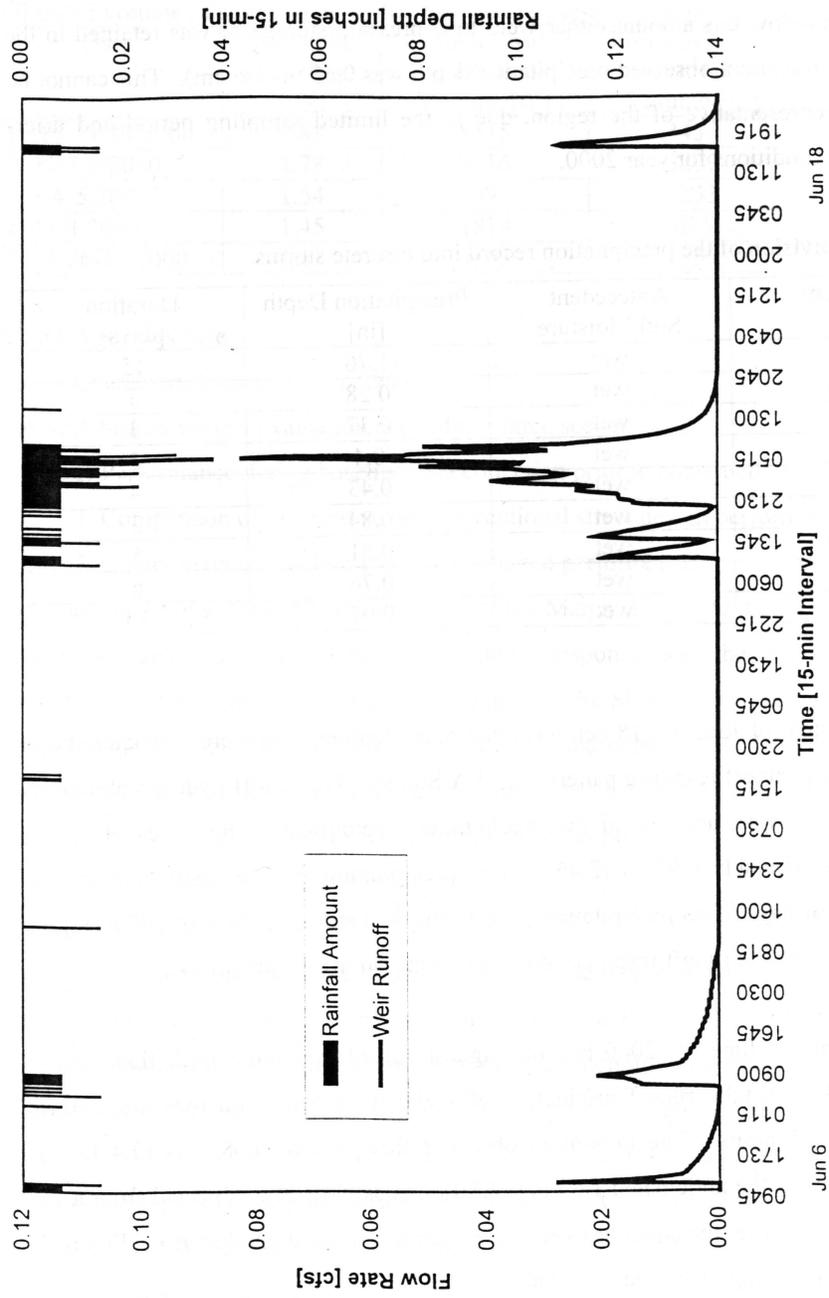
Figure 7-10: Precipitation hyetograph and runoff hydrograph for the SEA Streets Project
 June 6, 2000 (9:45 am) - June 18, 2000 (12:45 am)

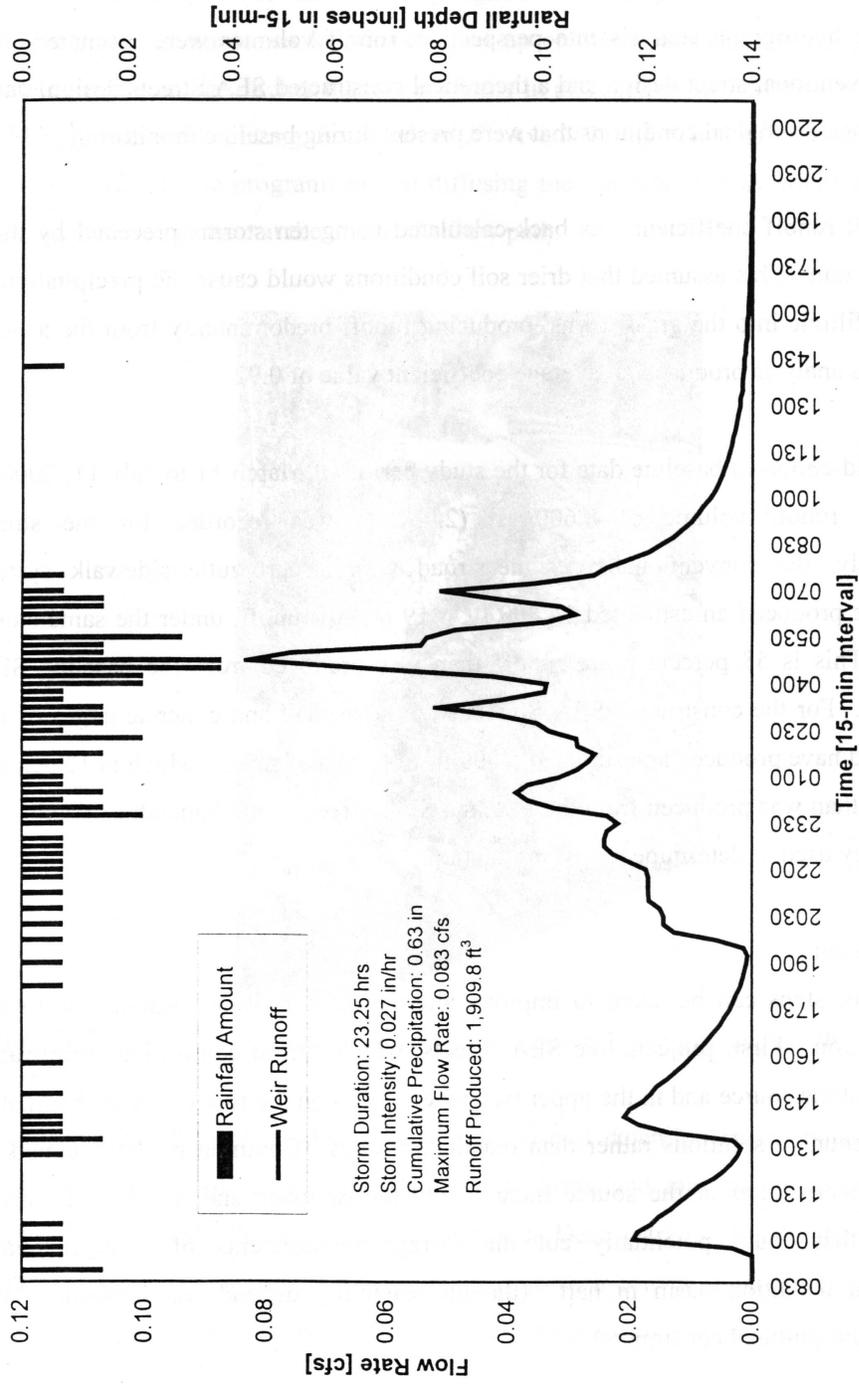
Figure 7-11: Highest-ranked precipitation and runoff for the SEA Streets Project
 June 11, 2000 (8:30 am) - June 12, 2000 (9:00 pm)

The third storm on June 11, 2000 had the highest-ranked maximum peak flow rate of 0.083 cfs (2.4 L/s), total runoff production of 1,910 ft³ (54 m³) and maximum storm duration of 23.25 hours. The maximum observed flow rate of 0.083 cfs (2.4 L/s) is significantly below the anticipated 1.5 cfs (42.5 L/s) peak flow rate expected from a 25-yr, 24-hr storm. Hence, the street has yet to experience any substantial storms. Figure 7-11 shows the hydrograph for June 11, 2000.

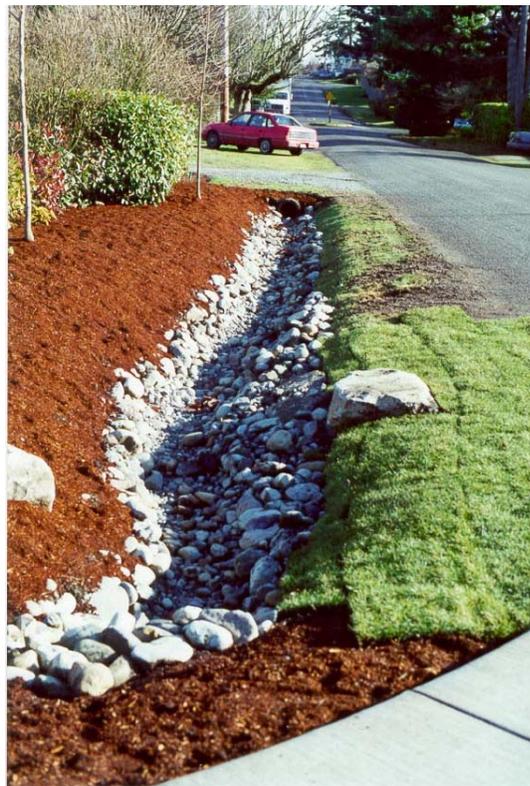
Figure 7-12: Swale system that replaced a concrete-lined open drainage ditch

Since more control can be made on city right-of-ways, similar smaller swale designs could be placed at numerous locations higher up on the watershed, replacing the open concrete-lined drainage ditches that are currently in place. One such system is located at the SEA Streets project along the length of 2nd Ave NW and NW 120th Street, as shown in Figure 7-12. These programs aim at diffusing the impacts of stormwater throughout the watershed, rather than at the end of the flow path.
